HOME INSPECTION REPORT

Your New Home
Greater Philadelphia, PA

69462

June 1, 2020

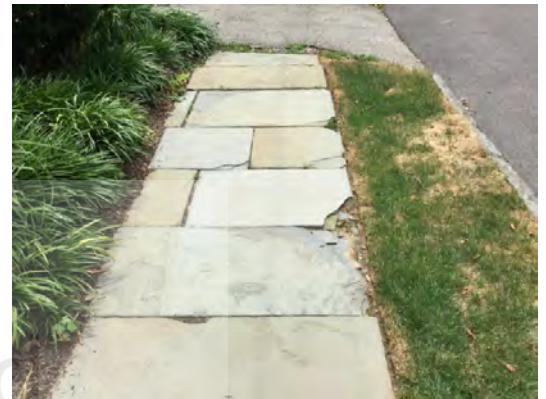
WALKWAY

Damage to the walkway observed. Recommend necessary repair/replacement.

1) Damage to the walkway observed. Recommend necessary repair/replacement. **FRONT EXTERIOR**
\$250 - \$500

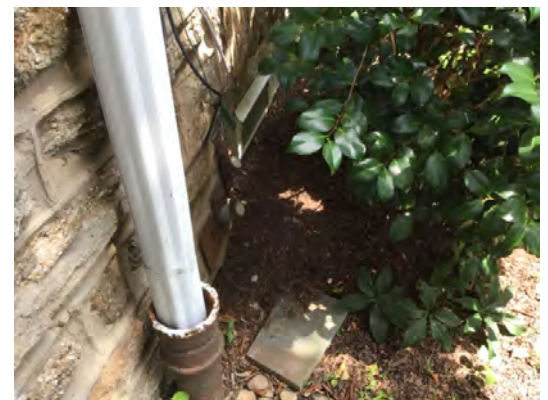
Window wells are advised for basement windows which are at or below grade level. Observed condition can promote moisture intrusion and damage to windows and/or building interior. Covers for the window wells is advised.

4) Window wells are advised for basement windows which are at or below grade level. Observed condition can promote moisture intrusion and damage to windows and/or building interior. Covers for the window wells is advised. **RIGHT EXTERIOR** \$400-\$700

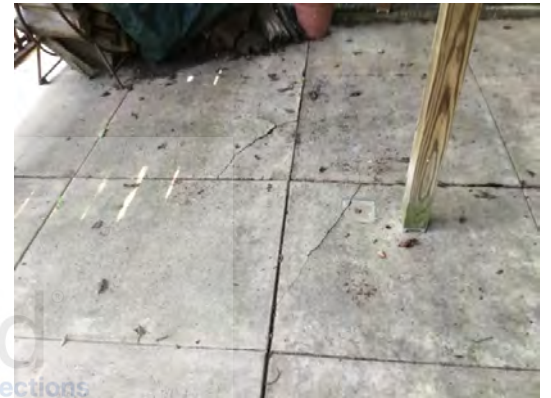
PATIO

Cracking in the patio observed. Sealing the cracks is advised to prevent additional cracking and damage.

7) Cracking in the patio observed. Sealing the cracks is advised to prevent additional cracking and damage. **REAR EXTERIOR** \$1000-\$1500

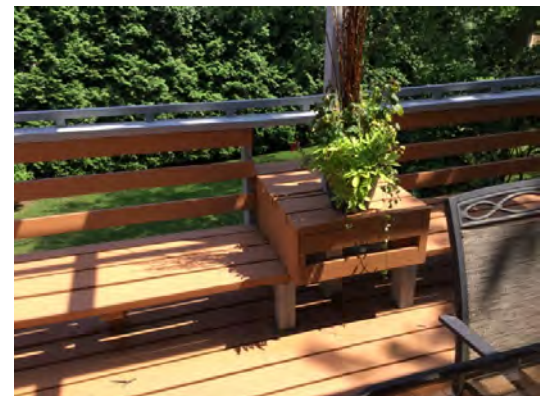
Railing system observed to have horizontally oriented infill components. Although horizontal railing infill is often permitted, the potential safety concern should be understood. Horizontal infill can encourage climbing. Young children are especially at risk. Corrective action to limit climbing and potential fall hazard strongly encouraged.

9) Railing system observed to have horizontally oriented infill components. Although horizontal railing infill is often permitted, the potential safety concern should be understood. Horizontal infill can encourage climbing. Young children are especially at risk. Corrective action to limit climbing and potential fall hazard strongly encouraged. **DECK**

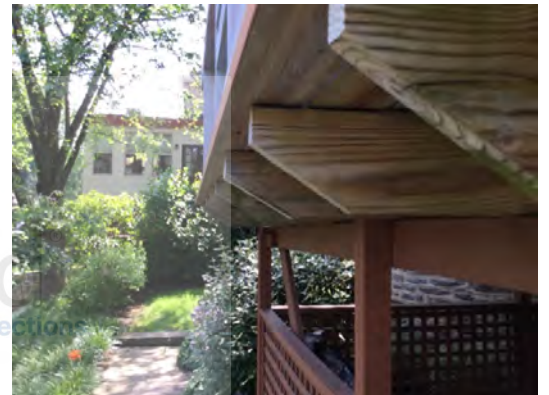
Openings greater than 4 inches observed in the railing system. Condition presents a potential fall/entrapment risk, especially for young children. Repair/replacement is advised for safety.

Joists were noted to be out of plumb and not flush with floor boards. Repairs by a qualified contractor are recommended.

10) Openings greater than 4 inches observed in the railing system. Condition presents a potential fall/entrapment risk, especially for young children. Repair/replacement is advised for safety. DECK \$250 - \$500

11) Joists were noted to be out of plumb and not flush with floor boards. Repairs by a qualified contractor are recommended. DECK \$200-\$300

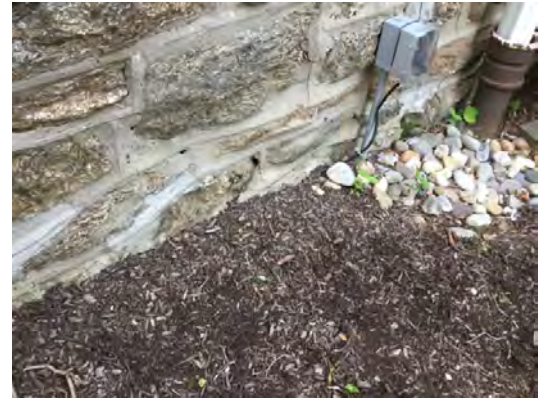
Deteriorated mortar joints should be pointed.

12) Deteriorated mortar joints should be pointed. PORCH \$150-\$250

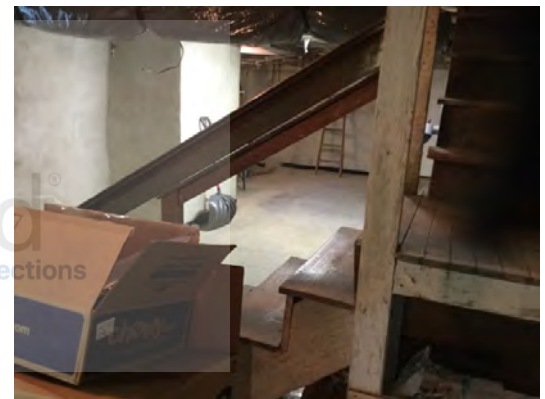
One or more absent baluster(s) observed in the railing system. Condition presents a potential fall risk, especially for young children. Repair/replacement is advised for safety.

15) One or more absent baluster(s) observed in the railing system. Condition presents a potential fall risk, especially for young children. Repair/replacement is advised for safety. BASEMENT \$100-\$200

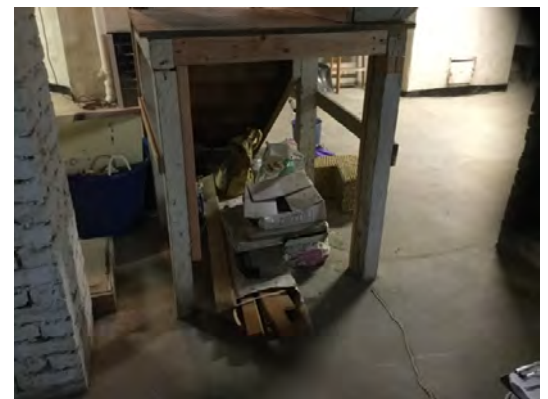
The stairway landing is out of plumb and not supported adequately. Repair is needed.

16) The stairway landing is out of plumb and not supported adequately. Repair is needed. BASEMENT \$50 - \$100

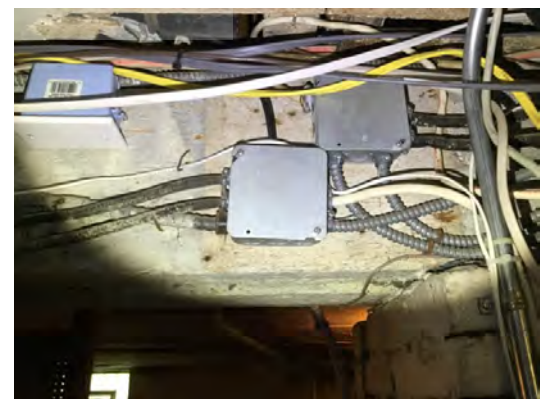
Knob-and-Tube wiring was observed. This type of wiring is known to be more prone to electrical problems and fire hazards. Further professional evaluation by a licensed electrician is advised for potential replacement, along with associated repair/replacement costs prior to settlement.

22) Knob-and-Tube wiring was observed. This type of wiring is known to be more prone to electrical problems and fire hazards. Further professional evaluation by a licensed electrician is advised for potential replacement, along with associated repair/replacement costs prior to settlement. BASEMENT PROFESSIONAL ESTIMATE RECOMMENDED

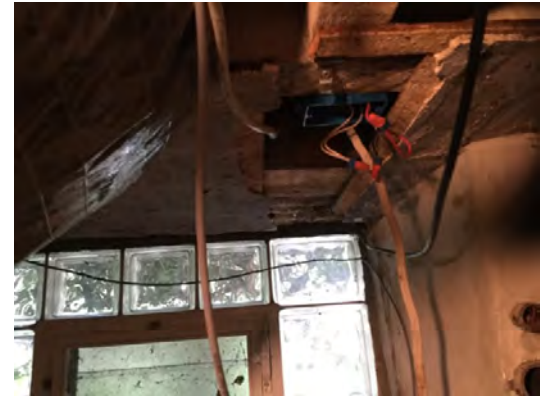
Uncovered junction box(es) observed. Installation of a cover is advised for safety and protection of the wire connections within the box.

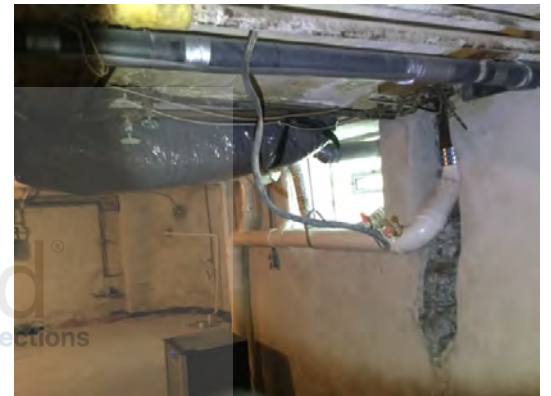
Abandoned wiring was noted. This wiring should be removed or properly terminated for improved safety.

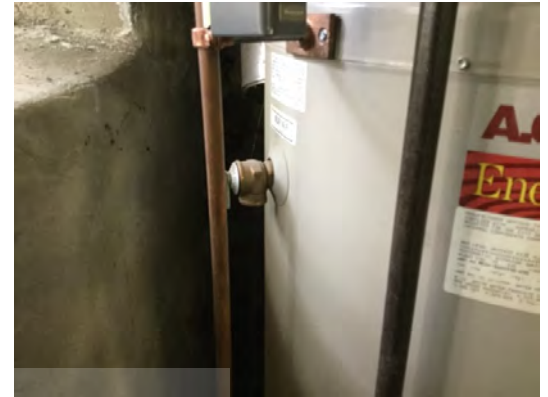
Temperature Pressure Relief extension was not observed. It is recommended that a proper TPR extension extending 4-6 inches from the floor be installed.

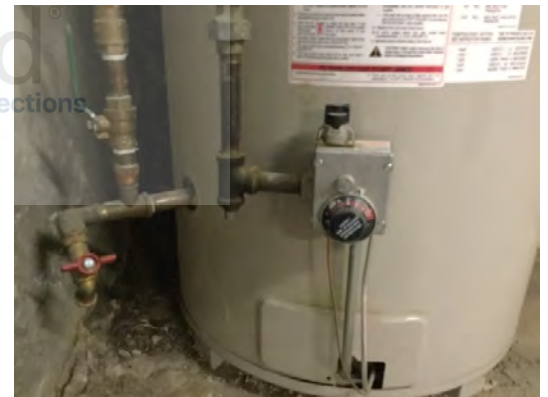
Sediment trap (aka Drip Leg) noted to be absent at the water heater. Sediment traps are required at gas appliances (except ranges, clothes dryers, gas powered lights and grills) to collect debris in the gas before the gas enters the metering valve of the appliance. Recommend installation by a qualified plumbing contractor.

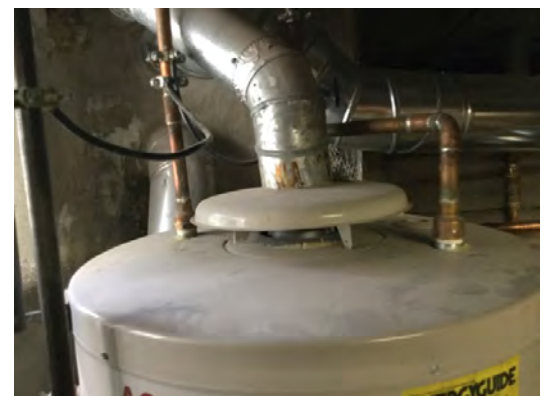
Spillage of exhaust products was noted at the draft hood. This hazardous condition will allow the toxic products of combustion (such as carbon monoxide) to enter the living space. Further professional evaluation and corrective action is advised to ensure the safety of property occupants.

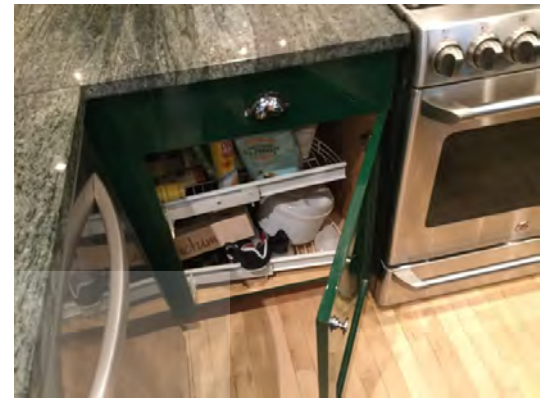
The loose cabinet door hinge should be secured.

18) The loose cabinet door hinge should be secured. KITCHEN

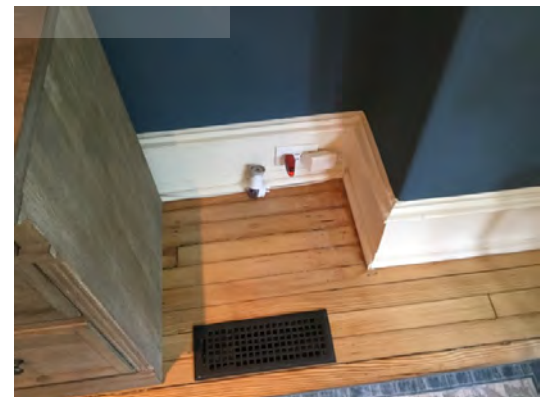
One or more receptacles tested ungrounded. Necessary corrective action is advised.

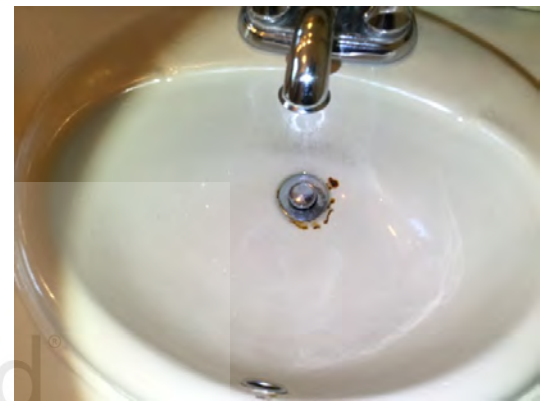
Sink basin observed to be corroded. Allow for repair/replacement as desired.

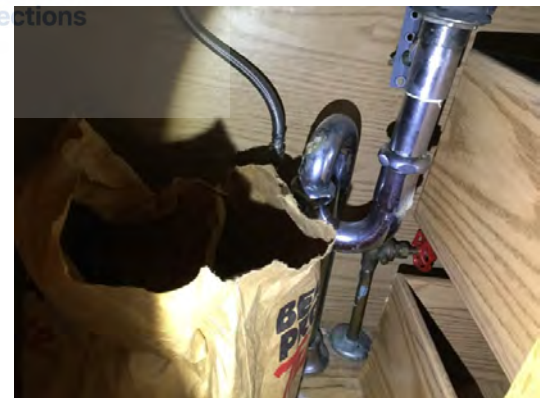
Corrosion observed at the sink drain. Condition should be monitored for future leakage. Preventative replacement may be desired.

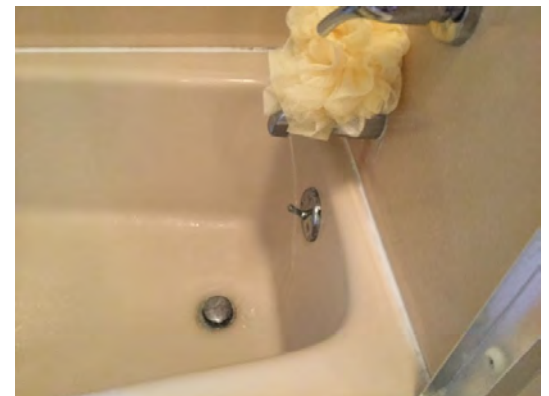
The diverter was noted to not be fully functional. All water should be directed to the shower when the diverter is engaged. Recommend necessary repair/replacement to restore proper function.

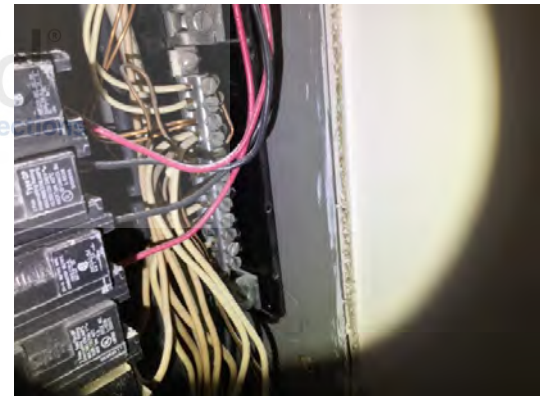
The neutral and ground wires were noted to be bonded in the sub panel. This configuration presents a hazardous condition. The bonding should be evaluated and corrected for proper safety.

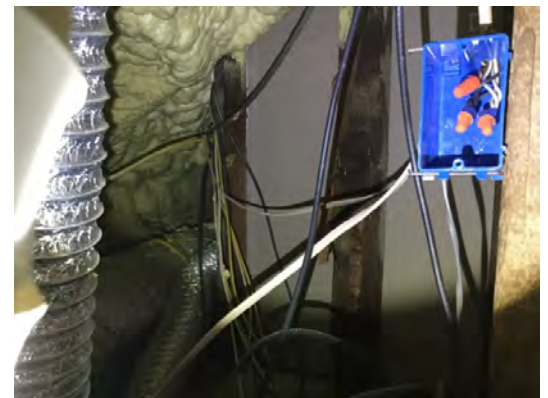
Uncovered junction box(es) observed. Installation of a cover is advised for safety and protection of the wire connections within the box.
