VALUEGUARD INSPECTIONS

RESIDENTIAL SAMPLE REPORT

1234 Main Street
Philadelphia, PA 19107

04/15/2025 9:00AM

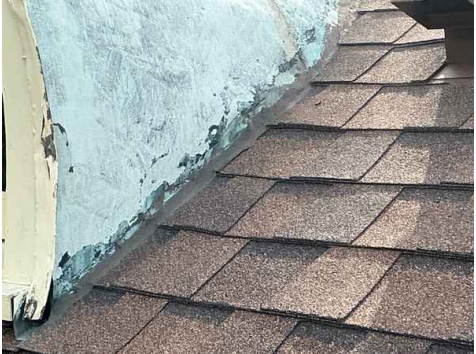
Roofing cement was observed to be used as a flashing material. Roofing cement should be considered temporary at best. A higher level of maintenance should be expected in this area until more permanent flashing is installed.

Estimated Cost
\$250 - \$500

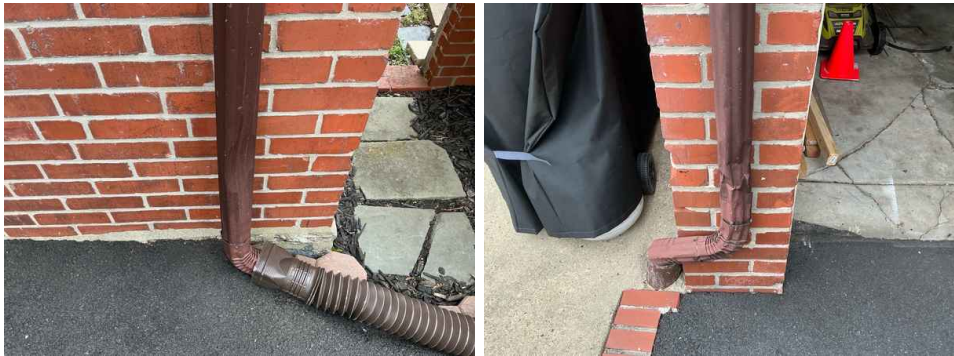
3.6.1 Roof Drainage

Damaged downspout(s) observed. Repair/replacement is advised to ensure proper function.

Estimated Cost
\$100 - \$250

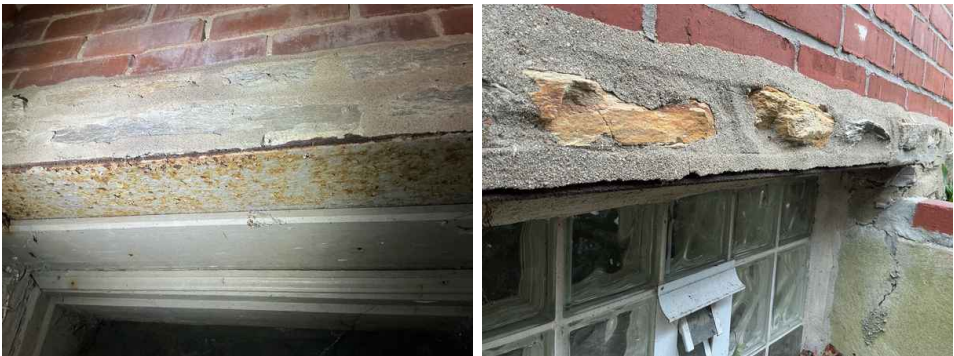
5.2.2 Masonry Exterior

LINTEL CORROSION

Rusted and/or corroded lintels above the windows and/or doors observed. If corrosion is allowed to progress the support strength of the lintel could become compromised. Painting of the lintels is advised with a rust inhibitive paint to prevent rust/corrosion.

Estimated Cost
\$500 - \$1,000

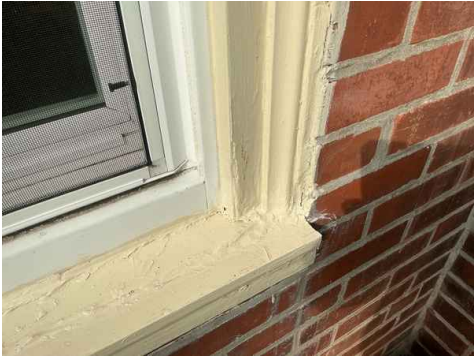
5.9.1 Exterior Window(s)

FRAME: DAMAGE/ROT

Window frame rot/damage observed. There is risk of hidden damage. Corrective action is advised.

Estimated Cost
\$250 - \$500

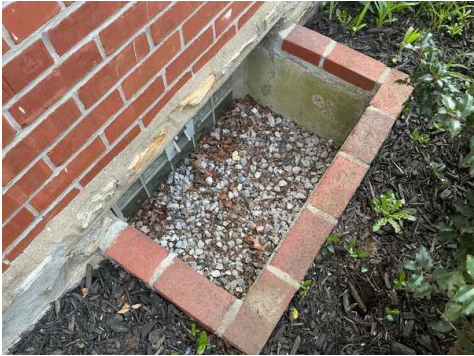
Removal of debris within window well(s) advised. Debris can contribute to poor drainage and possible moisture intrusion and damage.

Estimated Cost
\$100 - \$150

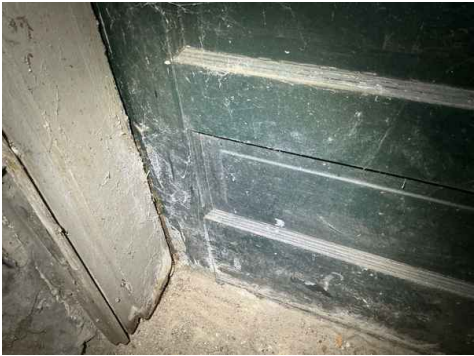
5.10.1 Exterior Door(s)

DOOR: DAMAGE/ROT

Damage/rot to the exterior door observed. Repair/replacement is advised.

Estimated Cost
\$250 - \$500

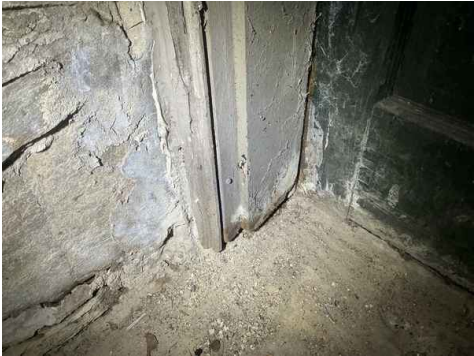
5.10.2 Exterior Door(s)

FRAME: ROT/DAMAGE

Exterior door frame rot/damage observed. There is risk of hidden damage. Corrective action is advised.

Estimated Cost
\$150 - \$250

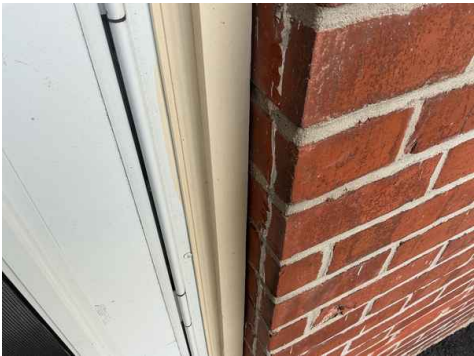
5.10.3 Exterior Door(s)

CAULKING: ABSENT

Door caulk/sealant observed to be absent. Condition risks moisture intrusion and damage. Sealant improvement is advised.

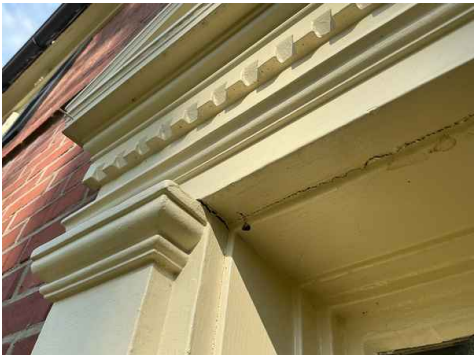
5.10.4 Exterior Door(s)

CAULKING: DAMAGED

Door caulk observed to be damaged. Condition risks moisture intrusion and damage.

Estimated Cost
\$100 - \$150

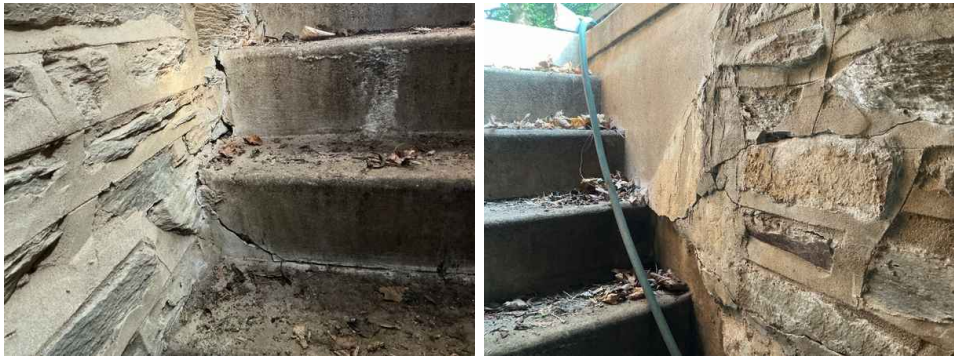
5.11.1 Exterior Stairs

STAIRS: DAMAGED MASONRY

Masonry damage observed at the stairs. Repairs are advised to prevent additional cracking and further damage.

Estimated Cost
\$500 - \$750

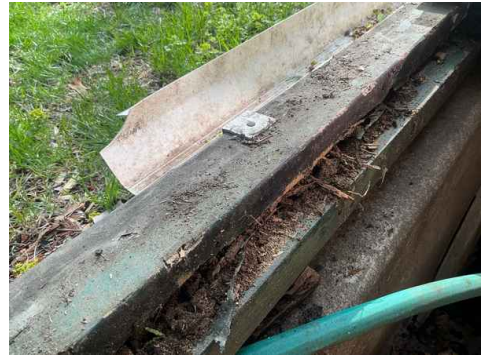
5.13.1 WDI/Pest

CARPENTER ANT ACTIVITY/DAMAGE (WDI INSPECTION NOT PERFORMED)

Evidence of suspected carpenter ant activity/damage observed. This inspection not a wood destroying insect/organism inspection and should not be relied upon as such. Hidden activity/damage is possible. Further professional evaluation by a licensed pest control specialist is advised. Allow for professional treatment and repairs as advised.

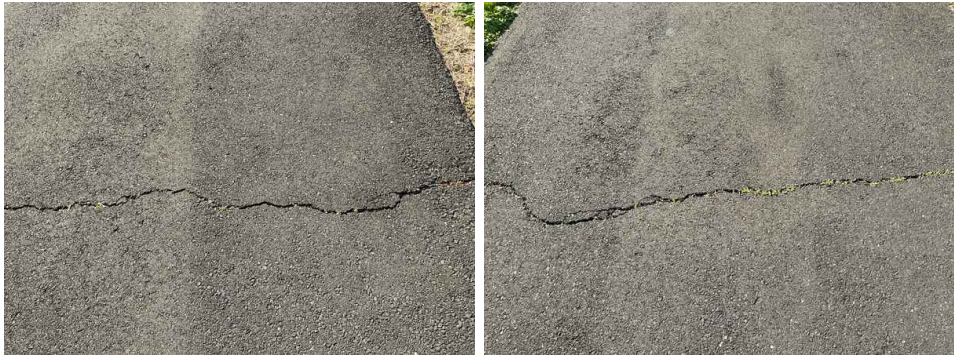
6.3.1 Driveway

DRIVEWAY: CRACKING

Cracking in the driveway observed. Sealing the cracks is advised to prevent additional cracking and damage.

Estimated Cost
\$250 - \$500

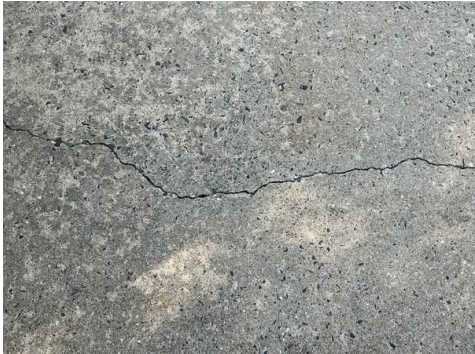
6.4.1 Patio

PATIO: CRACKING

Cracking in the patio observed. Sealing the cracks is advised to prevent additional cracking and damage.

Estimated Cost
\$100 - \$250

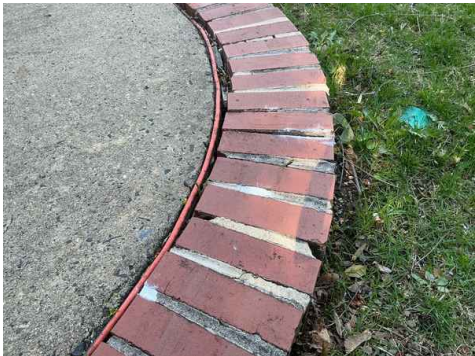
6.4.2 Patio

PATIO: MASONRY DAMAGE

Masonry damage to the patio observed. Recommend necessary repair/replacement.

Estimated Cost
\$250 - \$350

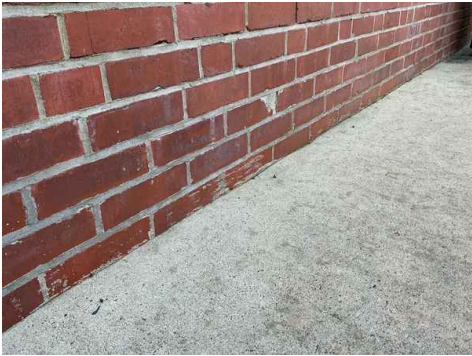
6.4.3 Patio

PATIO: SEALANT ADVISED

Sealant is advised at the transition of the patio and property exterior to prevent moisture intrusion and damage.

Estimated Cost
\$100 - \$150

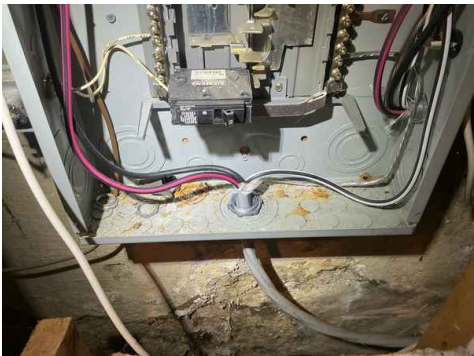
Rust/corrosion was noted in the electric service panel and/or panel components. This is a potential safety issues which requires further evaluation and necessary corrective action. The moisture source should be determined and necessary corrective action undertaken. Replacement of affected electric panel components may be advised.

Estimated Cost
\$100 - \$250

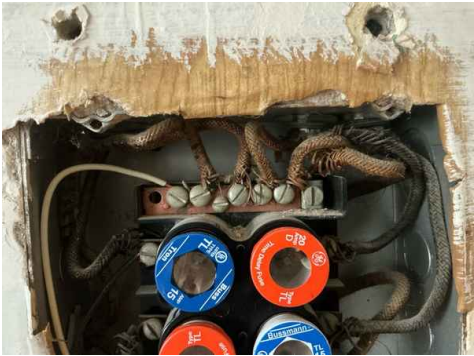
7.5.1 Sub-Panel - Basement Stairwell

GROUND/BOND: NEUTRALS NOT SEPARATED

The neutral and ground wires were noted to be bonded in the sub panel. This configuration presents a potentially unsafe condition. Further evaluation and necessary corrective action is advised.

Estimated Cost
\$100 - \$150

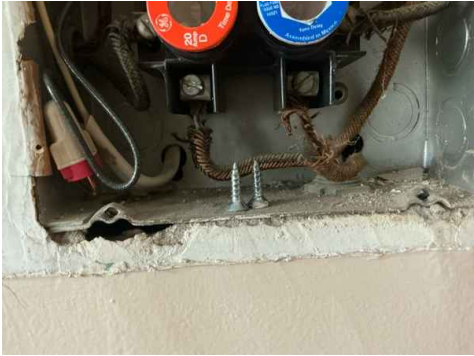
7.5.2 Sub-Panel - Basement Stairwell

SCREW: INCORRECT

Incorrect screw(s) was noted attaching the sub panel cover. Coarse threaded screws with pointed tips can penetrate the wiring in the panel and energize the panel, create wire damage and/or cause a short circuit. Incorrect screws should be replaced with appropriate size and type (blunt tip screws).

Estimated Cost
\$25 - \$50

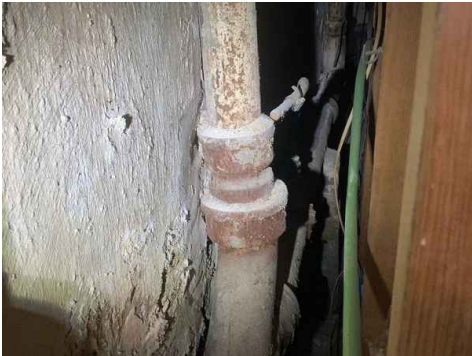
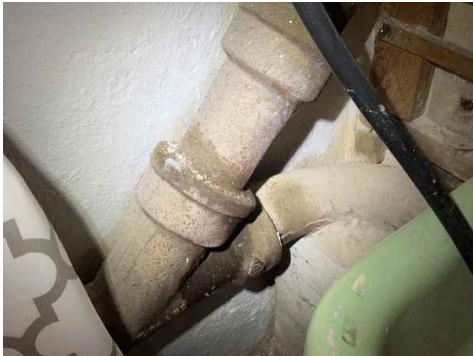
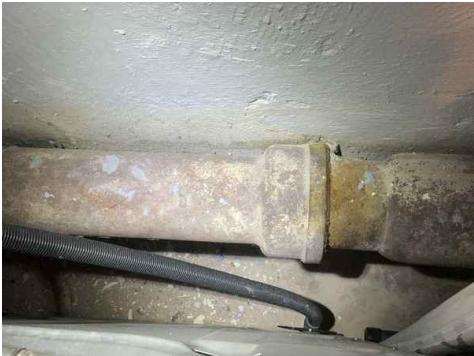
8.3.2 Waste and Drain Piping

WASTE: CORROSION

Corrosion observed on the waste piping. The presence of corrosion typically suggests that the waste piping is old and is beginning to deteriorate. Further professional evaluation along with necessary repair/replacement is advised.

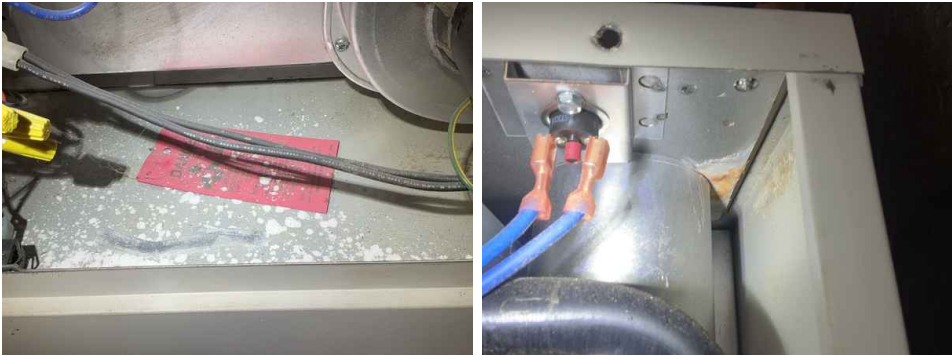
Corrosion observed at the interior of the furnace cabinet. Further evaluation is advised.

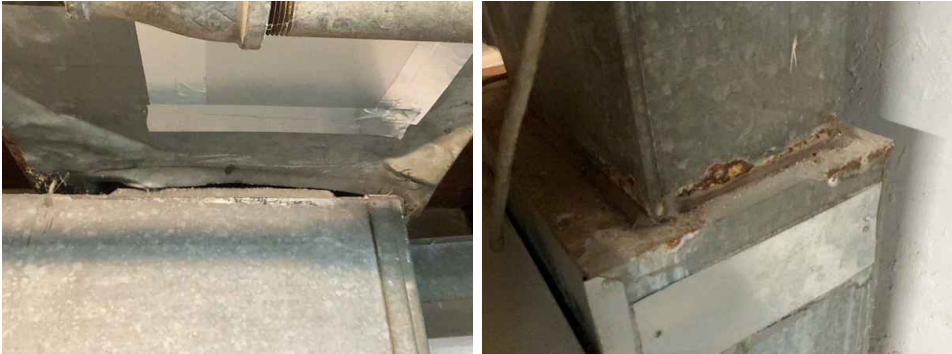
9.2.3 Furnace

DUCTWORK - DAMAGE/ CORROSION

Damage and corrosion noted at the ductwork. Evaluation and repairs by a qualified, licensed HVAC contractor are recommended.

Estimated Cost
\$250 - \$500

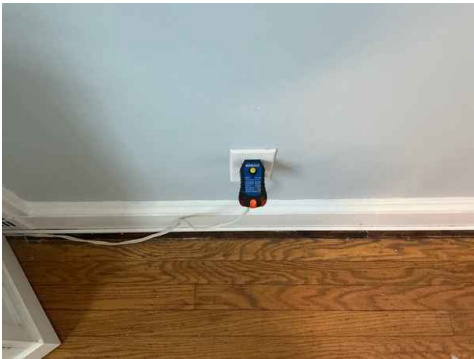
RECEPTACLE: UNGROUNDED 3 PRONG

Ungrounded 3 prong receptacle(s) were observed. Further evaluation and corrective action is advised.

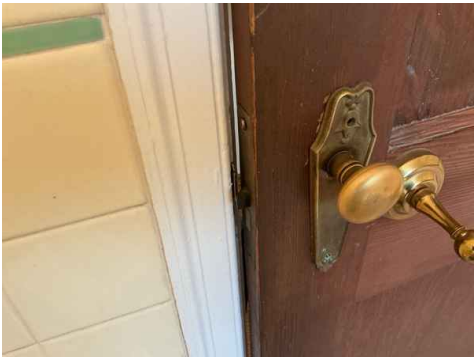
Latch adjustment/repair is advised for proper operation of the door. All interior doors should perform as intended.

Estimated Cost
\$100 - \$250

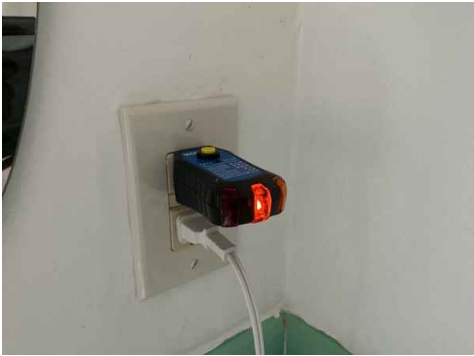
20.7.1 Interior Electrical

GFCI: TESTED FAULTY

GFCI receptacle(s) did not respond properly to test. Replacement is advised.

Estimated Cost
\$100 - \$150

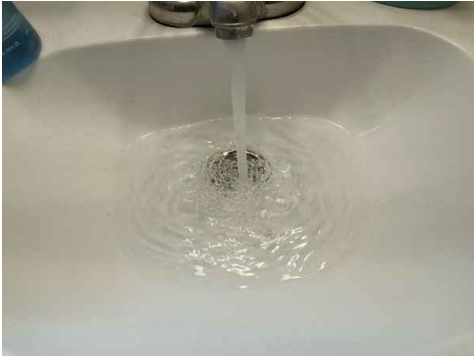
20.8.1 Sink

DRAIN: SLOW

Sink was observed to drain slowly typically indicating a restriction and/or venting issue. Recommend professional corrective action along with confirmation of proper operation.

Estimated Cost
\$100 - \$150

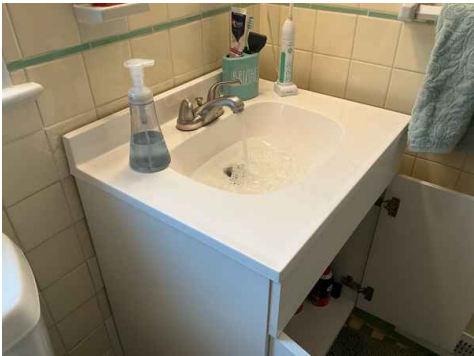
20.8.2 Sink

SINK: LOOSE

The sink is loose and should be secured.

Estimated Cost
\$100 - \$150

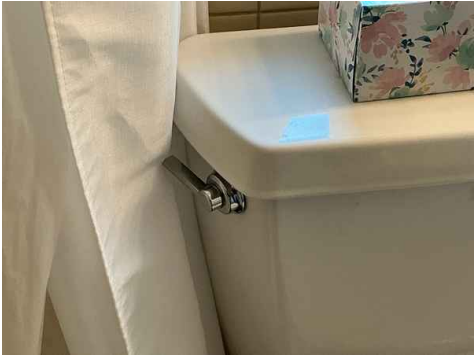
20.10.1 Toilet

OPERATION: FLUSH SLOW

Toilet flush was observed to be slower than typical. Recommend necessary corrective action and confirmation of proper function.

Estimated Cost
\$100 - \$150

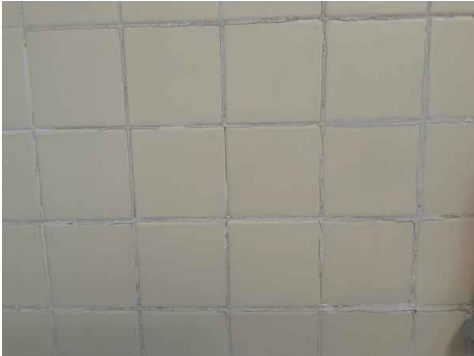
Grout improvement is advised at the shower to prevent moisture intrusion and damage.

Estimated Cost
\$250 - \$350

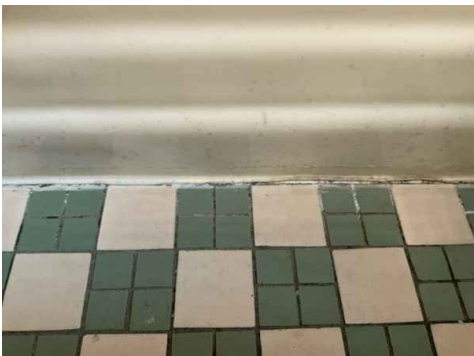
20.11.3 Tub/Shower

SEALANT/CAULK: IMPROVEMENTS

Improved sealant/caulk is advised at the shower to prevent moisture damage.

Estimated Cost
\$100 - \$150

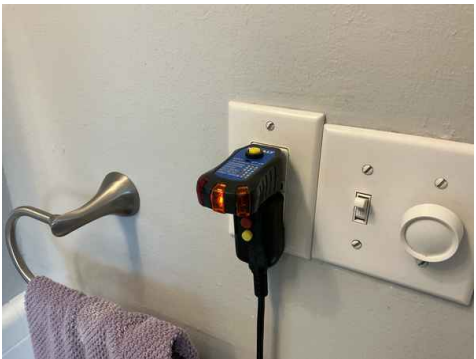
GFCI receptacle(s) did not respond properly to test. Replacement is advised.

Estimated Cost
\$100 - \$150

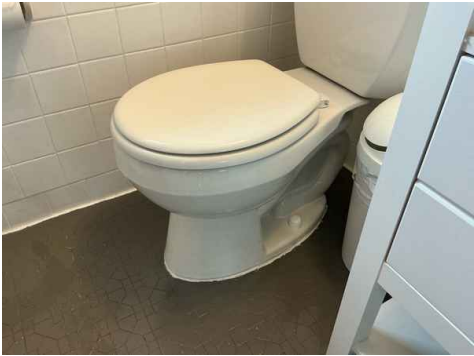
21.11.1 Toilet

INSTALLATION: LOOSE

Toilet was observed to be loose, a condition that risks leakage and moisture damage. Recommend re-installation of the toilet and seal. The toilet should be secure and stable.

Estimated Cost
\$100 - \$250

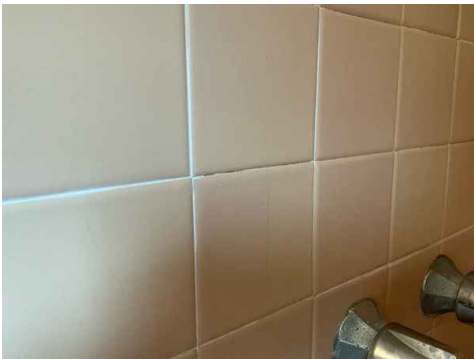
21.12.1 Shower

GROUT: IMPROVEMENTS

Grout improvement is advised at the shower to prevent moisture intrusion and damage.

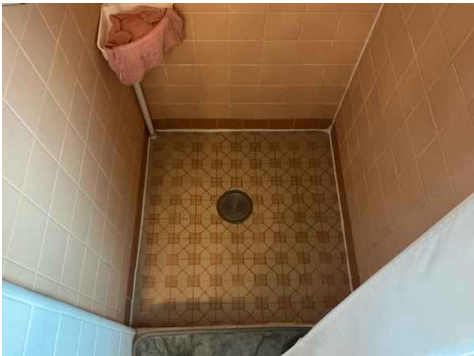
21.12.2 Shower

TILE: PRIOR REPAIRS

Evidence of prior tile repair observed at the shower. Recommend obtaining relevant information regarding repairs.

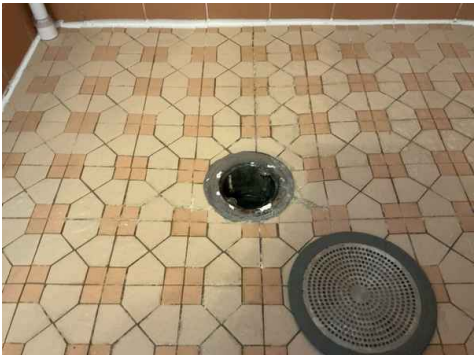
21.12.3 Shower

SHOWER DRAIN COVER - ABSENT

Fixed shower drain cover absent. Installation is recommended.

Estimated Cost
\$100 - \$150

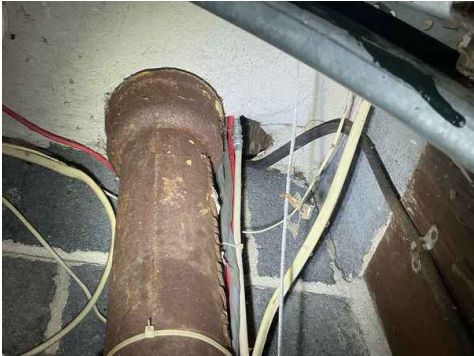
Openings were observed in the garage ceiling which may compromise the fire rating and may permit noxious gases to enter the living space. Repairs are advised for the safety of building inhabitants.

Estimated Cost
\$150 - \$250

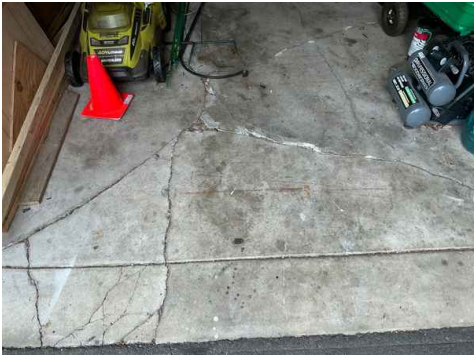
23.2.2 Ceiling/Walls/Floors

Extensive cracking observed in the garage floor. Professional repair/sealing the cracks is advised to prevent additional cracking and damage. Areas of cracking should be monitored. Further professional consultation is advised if cracks worsen or additional cracking is discovered.

Estimated Cost
\$500 - \$750

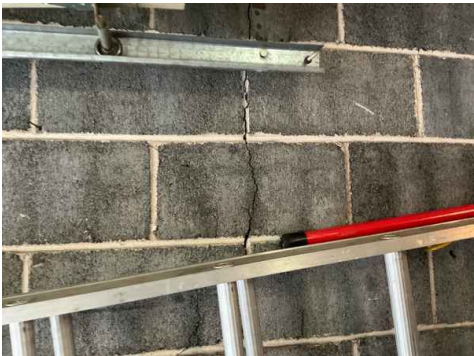
23.2.3 Ceiling/Walls/Floors

Cracking observed at the masonry wall. Recommend necessary repair.

Estimated Cost
\$150 - \$250

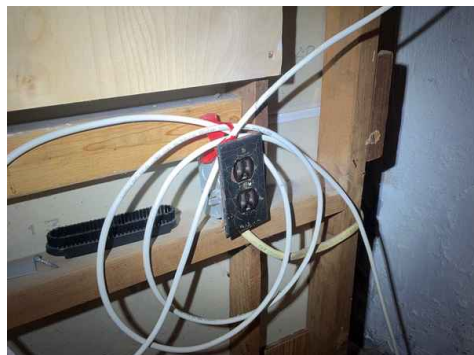
Absent GFCI receptacle protection observed in an advised location. Installation is advised.
