HOME INSPECTION REPORT

Your New Home
Greater Philadelphia, PA

69462

June 1, 2020

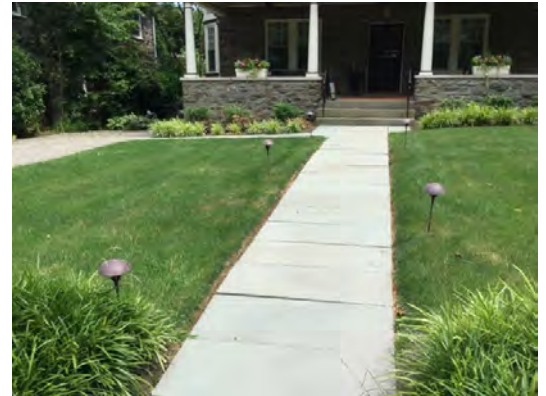
WALKWAY

Damage to the walkway observed. Recommend necessary repair/replacement.

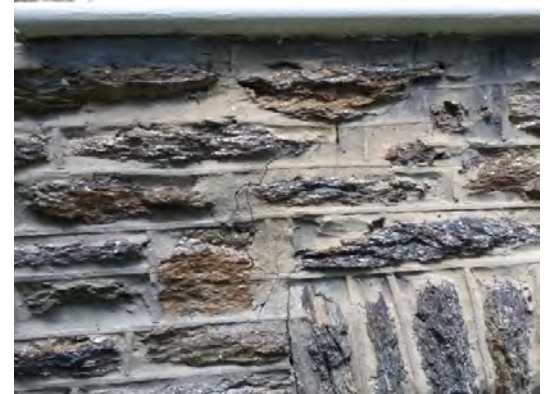
MASONRY

Hairline cracking observed. Professional repair/sealing the cracks is advised to prevent additional cracking and damage. Areas of cracking should be monitored. Further professional consultation is advised if cracks worsen or additional cracking is discovered.

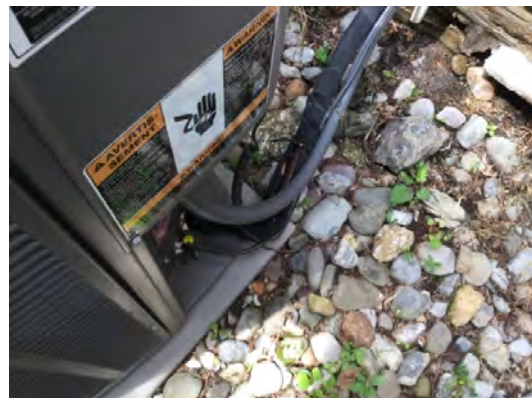
CONDENSER - LEFT

Damaged or absent insulation was noted on the refrigerant tubing at the condenser. This may reduce the efficiency of the cooling system, promote condensation and/or promote ice formation on the refrigerant line. Allow for necessary repair/replacement.

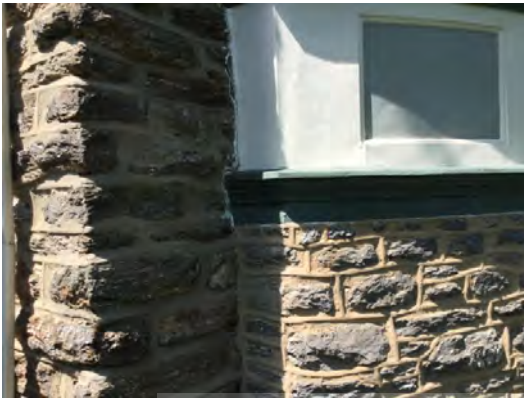
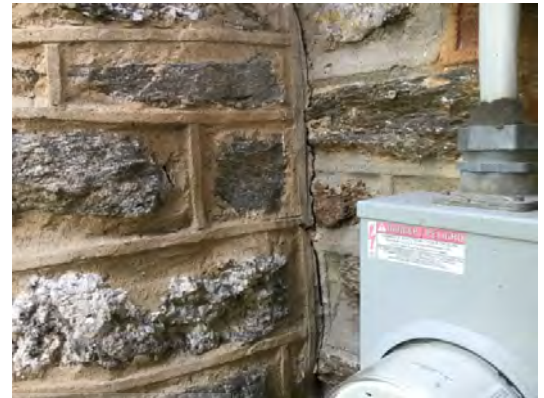
MASONRY

Cracking observed. Professional repair/sealing the cracks is advised to prevent additional cracking and damage. Areas of cracking should be monitored. Further professional consultation is advised if cracks worsen or additional cracking is discovered.

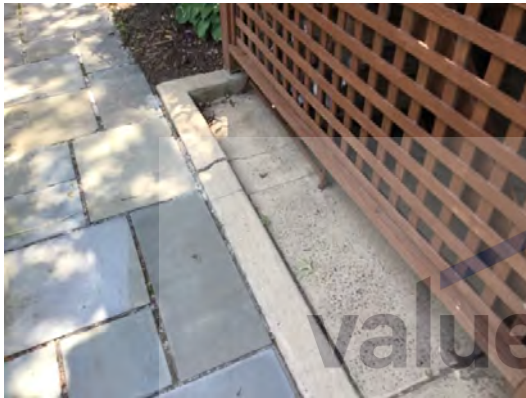
PATIO

Cracking in the patio observed. Sealing the cracks is advised to prevent additional cracking and damage.

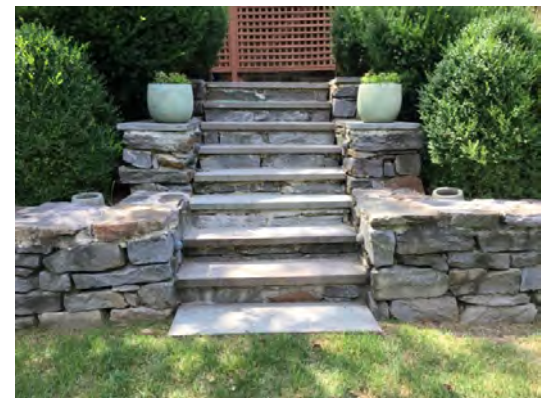
EXTERIOR STAIRS

Absent handrail(s) observed. Graspable handrail(s) are advised at stairs which have 4 or more risers for safety.

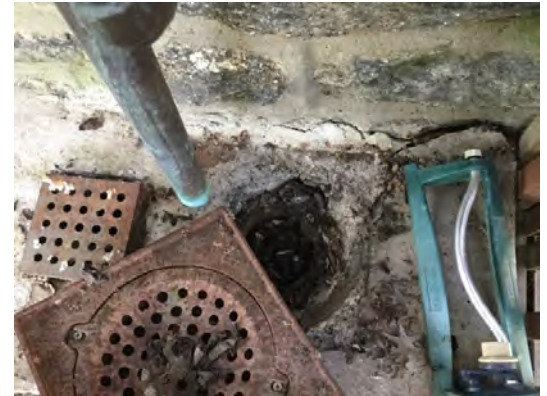
EXTERIOR DRAIN

The exterior drain was observed to be clogged/obstructed. The drain should be cleared as necessary. Keeping the drains clear of debris is imperative to proper water management around the building. If the drains do not appear to perform as intended, further professional evaluation is advised for necessary corrective measures. It may be desired to have the drains video scoped prior to settlement to better understand the overall condition.

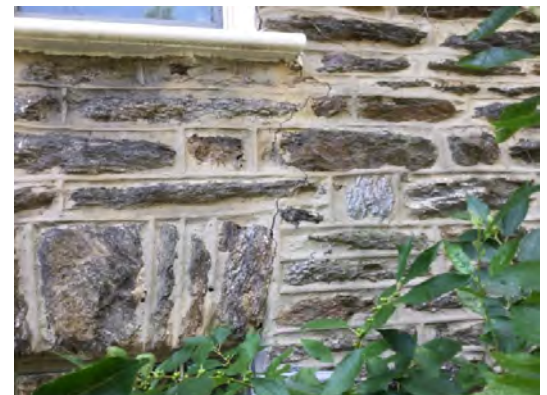
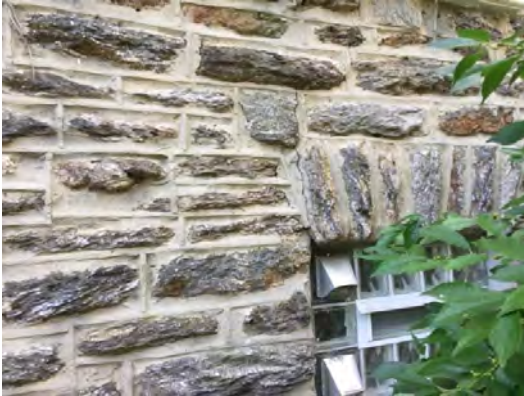
MASONRY

Cracking observed. Professional repair/sealing the cracks is advised to prevent additional cracking and damage. Areas of cracking should be monitored. Further professional consultation is advised if cracks worsen or additional cracking is discovered.

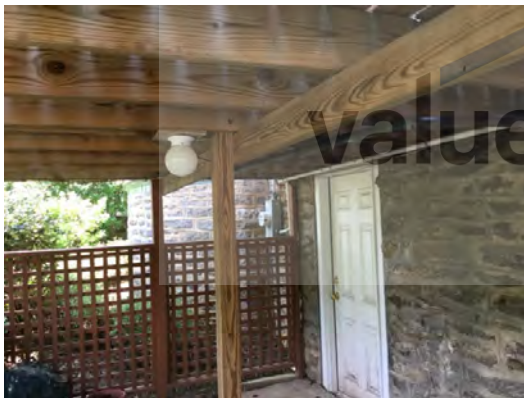
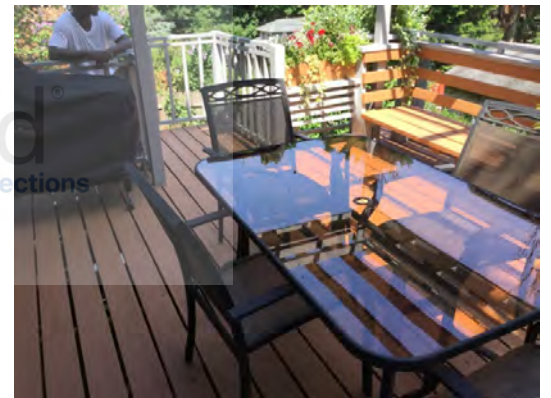
Wood Decking

Railing system observed to have horizontally oriented infill components. Although horizontal railing infill is often permitted, the potential safety concern should be understood. Horizontal infill can encourage climbing. Young children are especially at risk. Corrective action to limit climbing and potential fall hazard strongly encouraged.

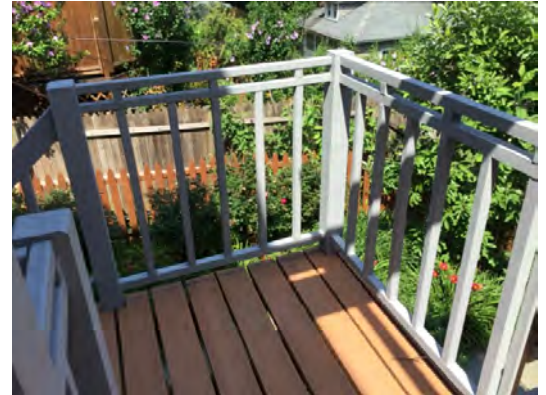
Openings greater than 4 inches observed in the railing system. Condition presents a potential fall/entrapment risk, especially for young children. Repair/replacement is advised for safety.

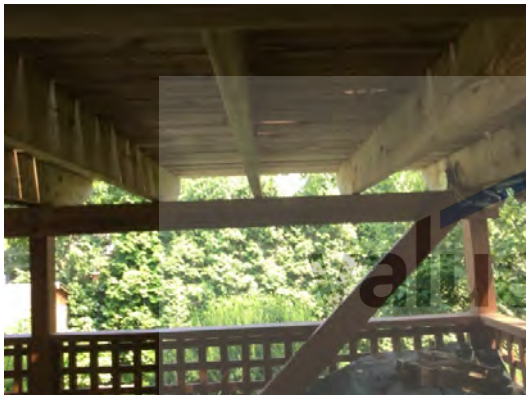
Joists were noted to be out of plumb and not flush with floor boards. Repairs by a qualified contractor are recommended.

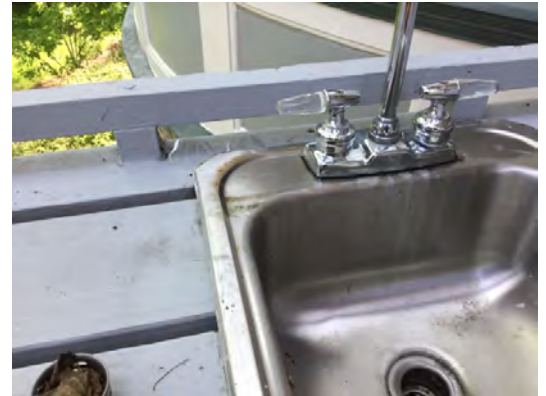
Leakage observed at the sink faucet. Recommend repair/replacement.

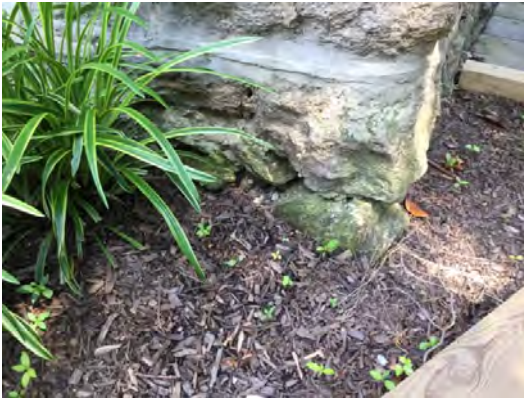
Deteriorated mortar joints should be pointed.

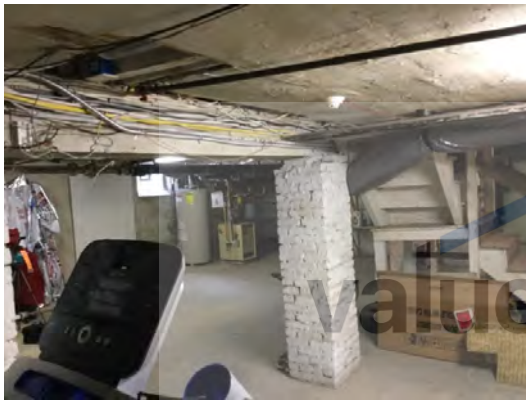
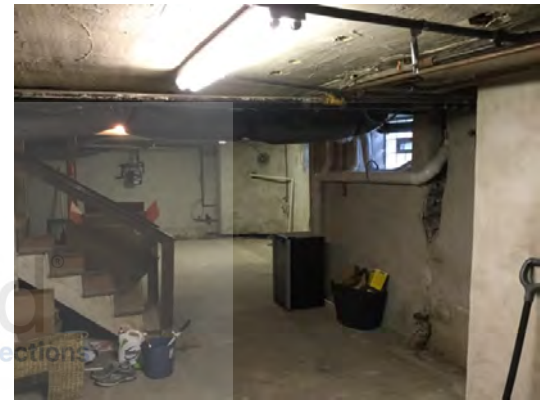
The basement shows evidence of moisture penetration. ***It should be understood that it is impossible to predict the severity or frequency of moisture penetration on a one-time visit to a home.*** Virtually all basements exhibit signs of moisture penetration and virtually all basements will indeed leak at some point in time. Further monitoring of the foundation will be required to determine what improvements, if any, will be required. Inspection of the basement is based on what is accessible and visible at the time of the inspection only. It does not preclude or warranty against the possibility of future moisture intrusion/penetration.

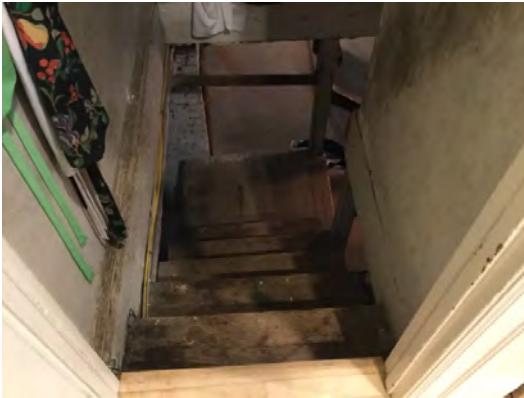
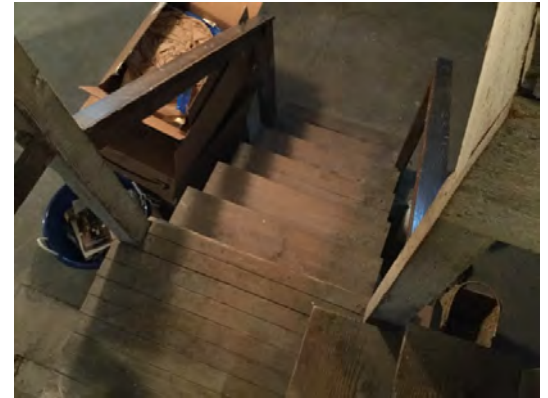
Absent handrail(s) observed. Graspable handrail(s) are advised at stairs which have 4 or more risers for safety.

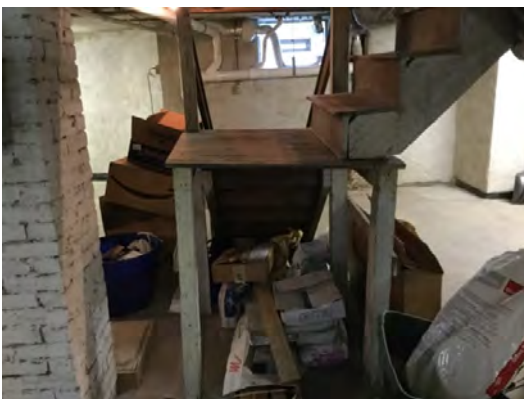
The stairway landing is out of plumb and not supported adequately. Repair is needed.

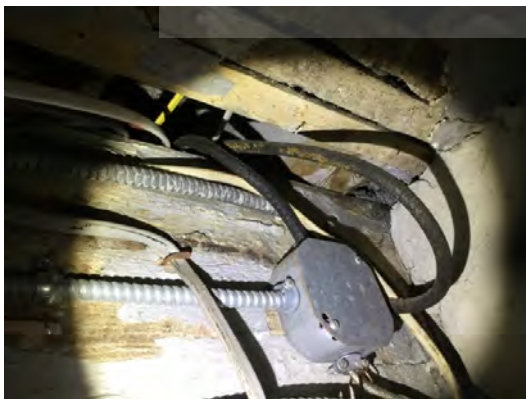
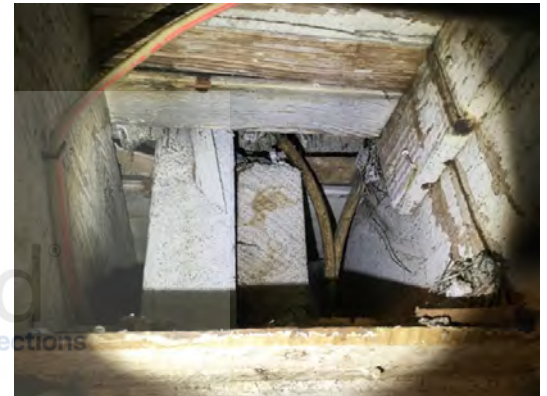
Knob-and-Tube wiring was observed. This type of wiring is known to be more prone to electrical problems and fire hazards. Further professional evaluation by a licensed electrician is advised for potential replacement, along with associated repair/replacement costs prior to settlement.

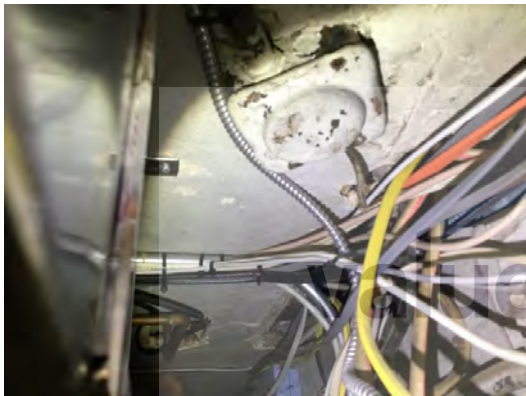
Abandoned wiring was noted. This wiring should be removed or properly terminated for improved safety.

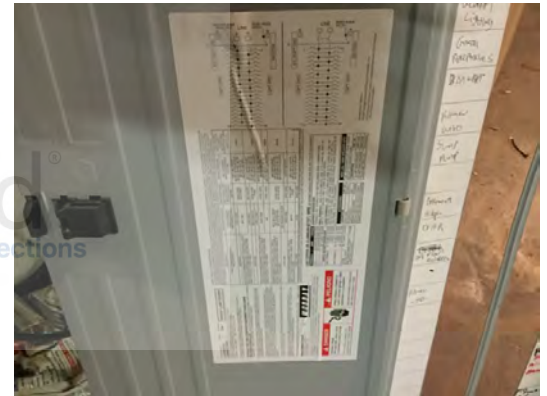
The panel was partially labeled. Recommend properly labeling the panel.

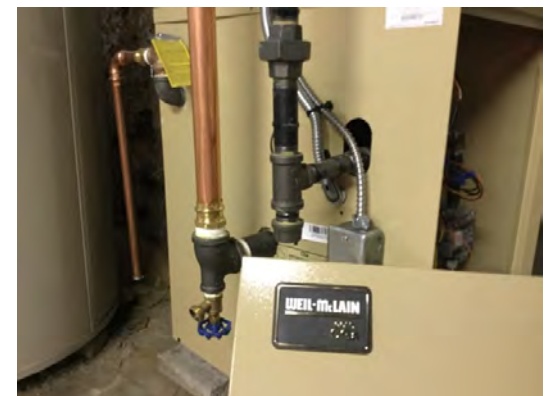
The missing sediment trap should be replaced.

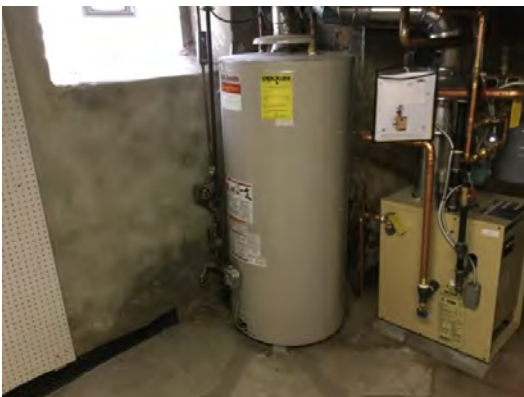
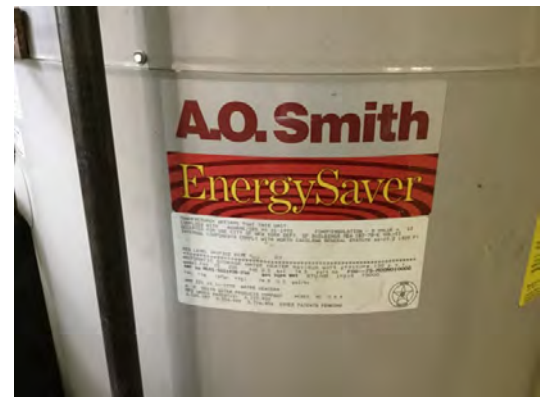
Water heater is approximately 18 years old. Expected service life for a water heater is 8-12 years. Due to the age of the water heater we recommend reserving funds for possible near term increased maintenance and/or replacement.

Temperature Pressure Relief extension was not observed. It is recommended that a proper TPR extension extending 4-6 inches from the floor be installed.

Sediment trap (aka Drip Leg) noted to be absent at the water heater. Sediment traps are required at gas appliances (except ranges, clothes dryers, gas powered lights and grills) to collect debris in the gas before the gas enters the metering valve of the appliance. Recommend installation by a qualified plumbing contractor.

Spillage of exhaust products was noted at the draft hood. This hazardous condition will allow the toxic products of combustion (such as carbon monoxide) to enter the living space. Further professional evaluation and corrective action is advised to ensure the safety of property occupants.

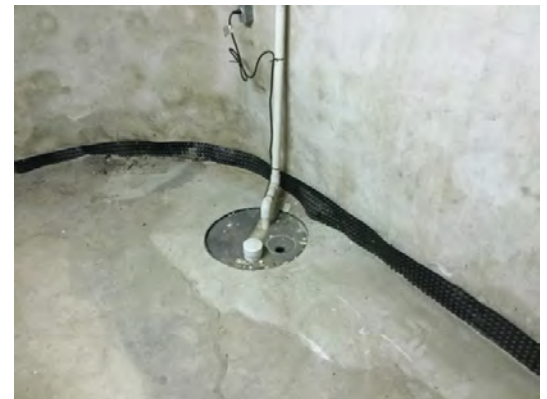
Access to the sump pump was not provided preventing confirmation of proper installation and/or operation. Further professional evaluation of the pump is advised for potential defects prior to settlement.

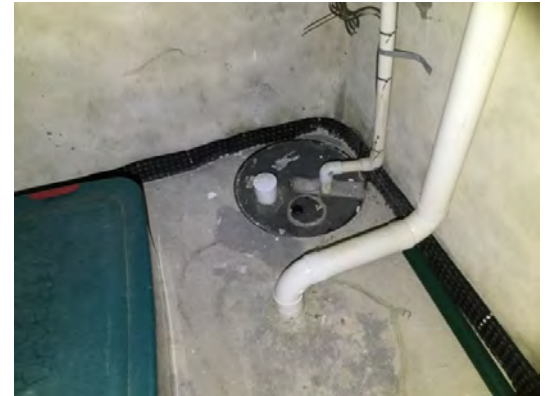
Access to the sump pump was not provided preventing confirmation of proper installation and/or operation. Further professional evaluation of the pump is advised for potential defects prior to settlement.

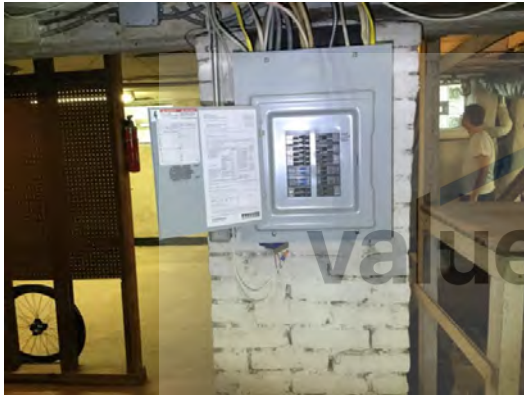
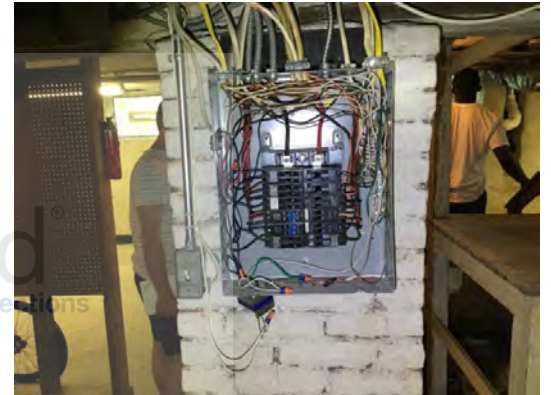
The panel was partially labeled. Recommend properly labeling the panel.

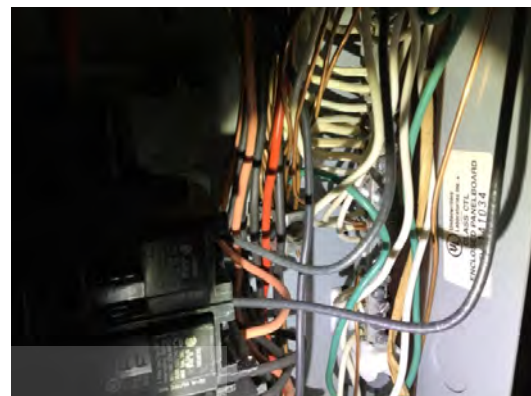
The neutral and ground wires were noted to be bonded in the sub panel. This configuration presents a hazardous condition. The bonding should be evaluated and corrected for proper safety.

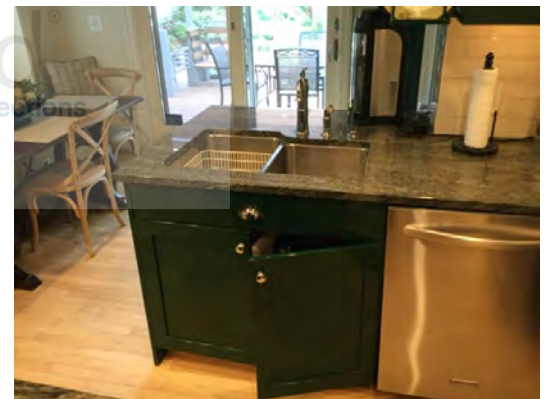
Corrosion observed at the sink drain. Condition should be monitored for future leakage. Preventative replacement may be desired.

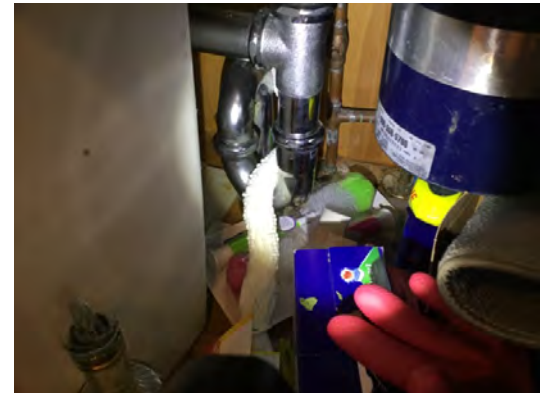
Waste disposer noted to be abnormally noisy during operational testing. Necessary repair/replacement is advised.

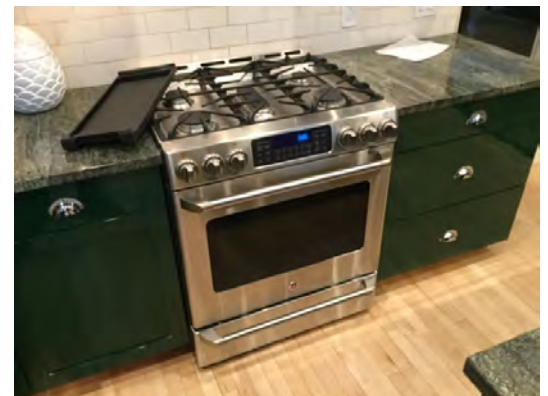
An anti-tip bracket was absent or improperly installed for the range. Installation of an anti-tip bracket is advised for safety.

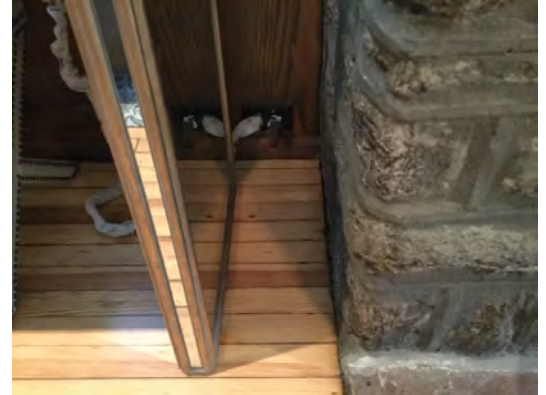
One or more receptacles noted to not have power at the time of the inspection. Allow for necessary corrective action.

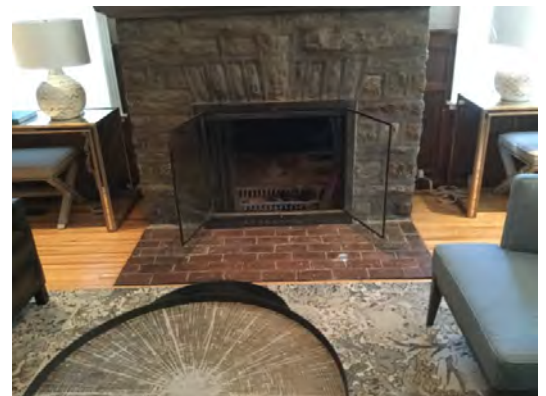
Recommend cleaning and inspection by a qualified chimney sweep to ensure a safe and functional chimney.

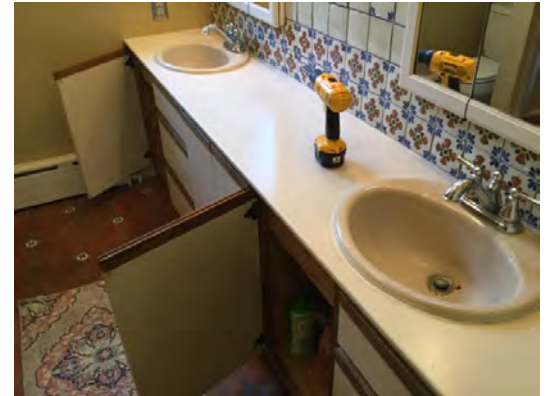
Sink basin observed to be corroded. Allow for repair/replacement as desired.

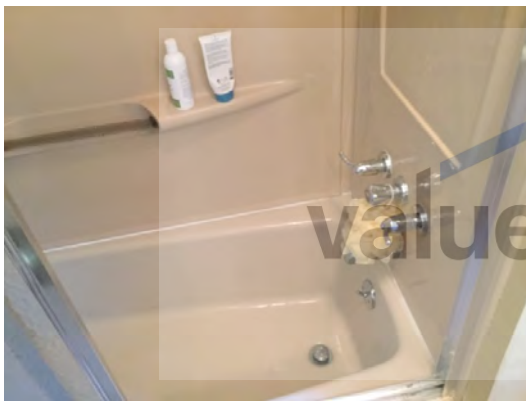
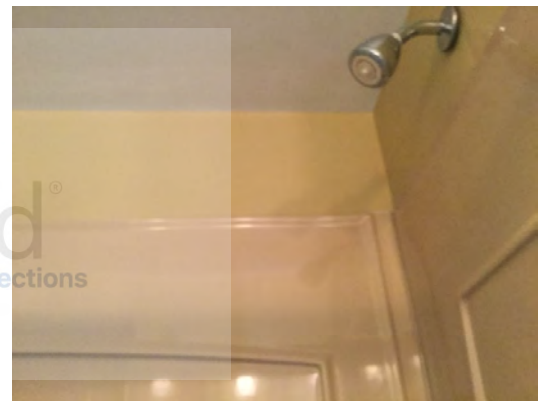
The diverter was noted to not be fully functional. All water should be directed to the shower when the diverter is engaged. Recommend necessary repair/replacement to restore proper function.

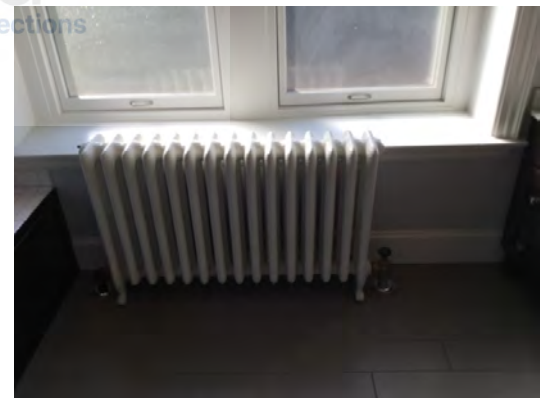
Insufficient heat noted at the radiator. Further professional evaluation and necessary repair is advised.

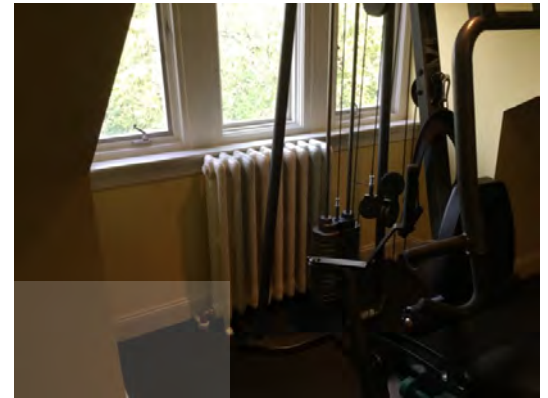
RADIATOR

Insufficient heat noted at the radiator. Further professional evaluation and necessary repair is advised.

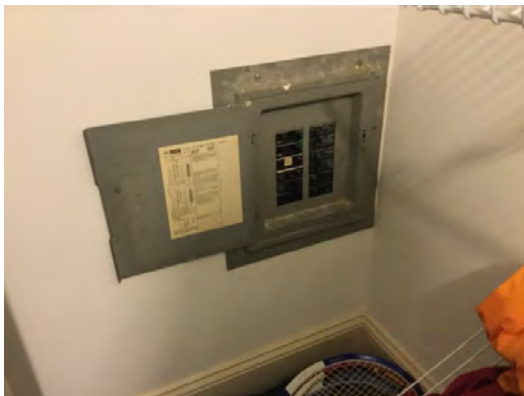
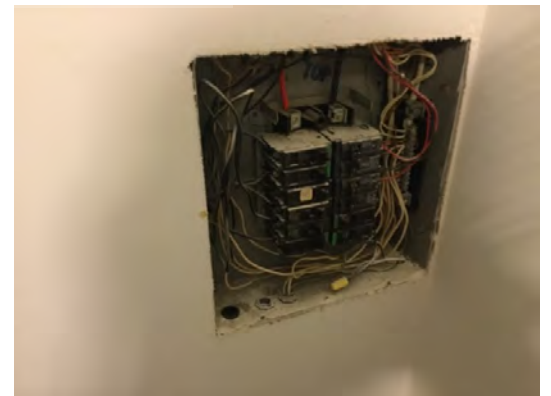
SUB PANEL

Panel Location: Closet

Electric panels with overcurrent protection devices should not be located in closets or bathrooms. The service panel at should be evaluated by a qualified electrician.

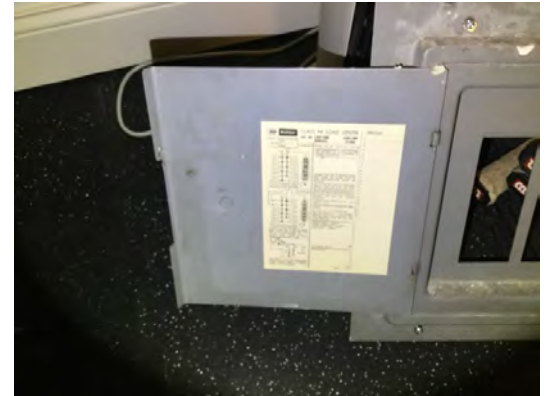
The data plate was visible at the time of this inspection.

Sub Panel Rating: 100 amp

The neutral and ground wires were noted to be bonded in the sub panel. This configuration presents a hazardous condition. The bonding should be evaluated and corrected for proper safety.

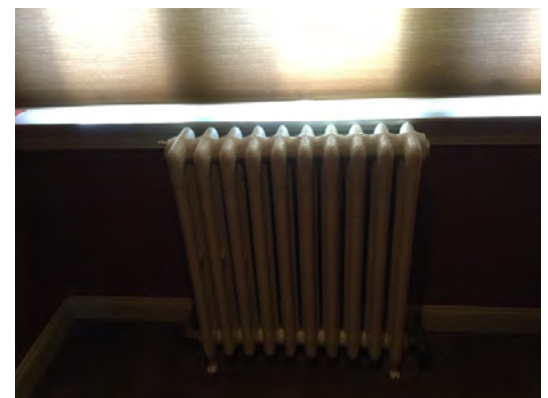
RADIATOR

Insufficient heat noted at the radiator. Further professional evaluation and necessary repair is advised.

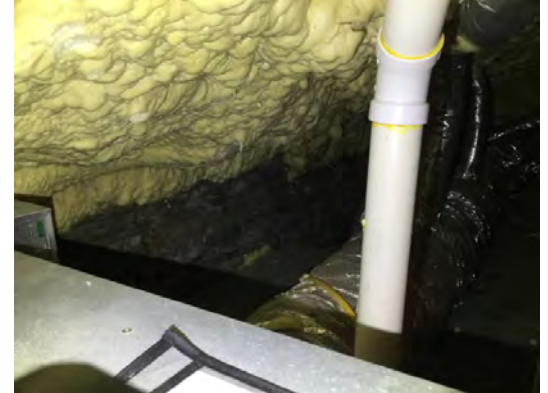
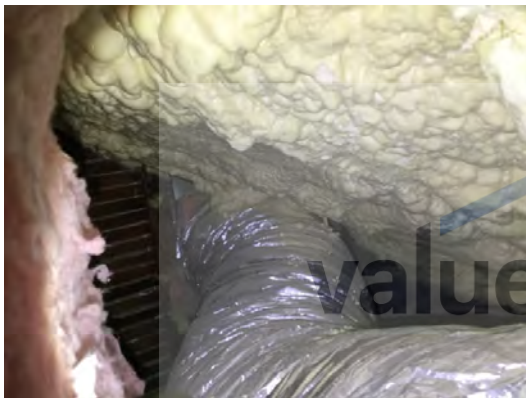
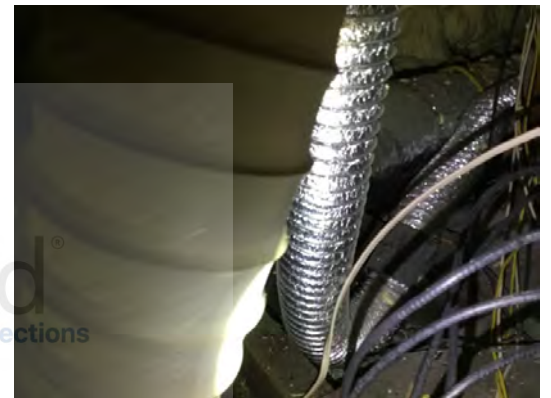
ATTIC - KNEE WALL

Insulation limited visual inspection.

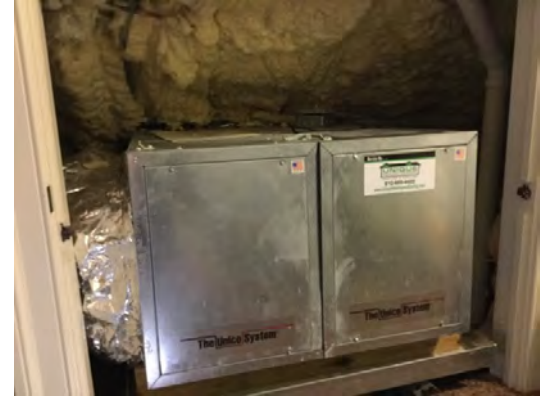
AIR HANDLER

Manufacturer: Unico

The access panel for the air handler blower section was not removed. Any defects relative to the air handler blower were not inspected. Recommend that a qualified HVAC technician gain access to the air handler burner before settlement to confirm its condition and operation.
