VALUEGUARD INSPECTIONS

RESIDENTIAL SAMPLE REPORT

1234 Main Street
Philadelphia, PA 19107

04/15/2025 9:00AM

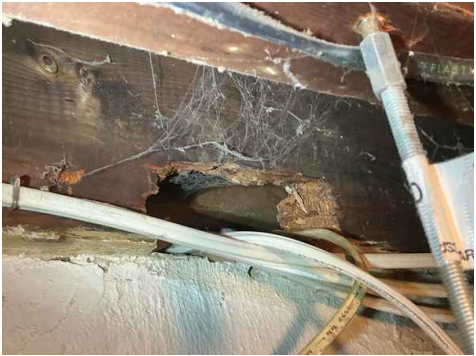
2.2.1 Floor/Wall/Ceiling Structure

JOIST: ALTERED

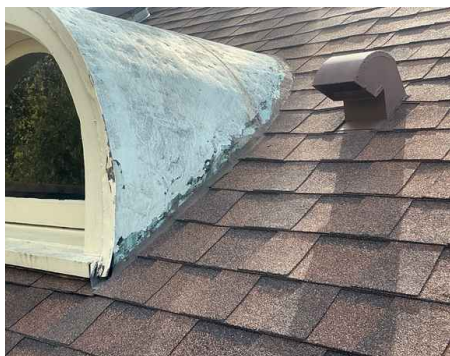
Roof: Prior Repairs Observed

Evidence of prior roofing repairs observed possibly indicating previous issues. Recommend obtaining relevant information regarding repairs along with warranties which may be applicable.

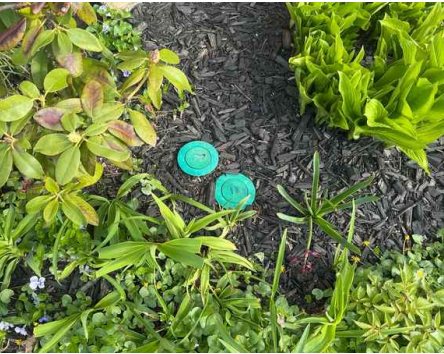
Bait stations and/or other pest/rodent control measures have been observed. We recommend that you obtain all relevant information regarding any prior infestations, as well as details on any existing warranties or contracts related to pest control services.

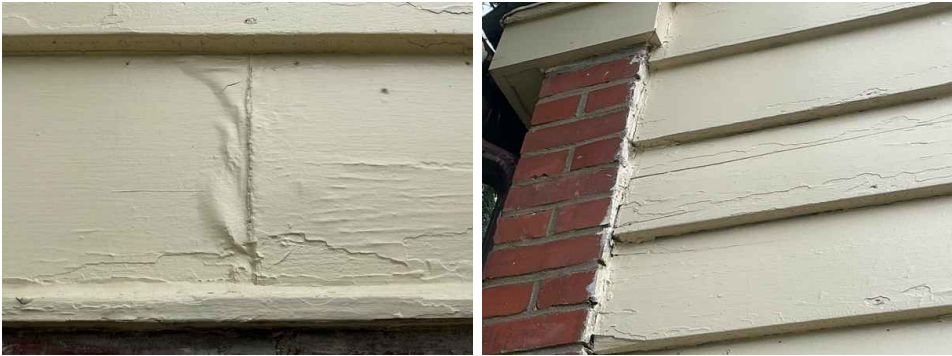
5.4.1 Trim/Soffit/Fascia/Eaves

TRIM: DAMAGE

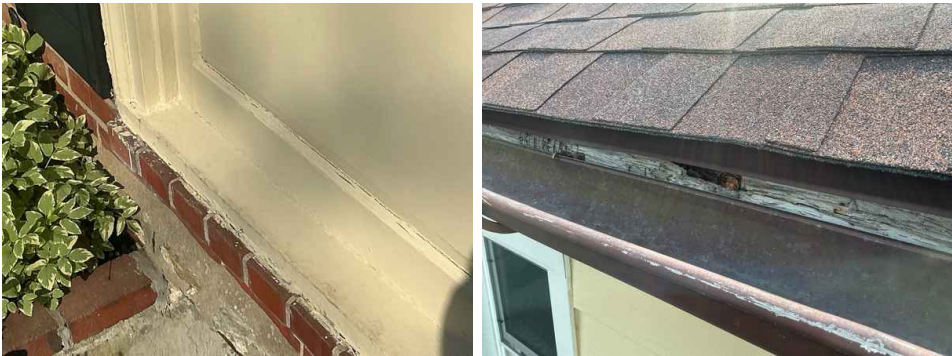
5.4.2 Trim/Soffit/Fascia/Eaves

EAVES: PEELING/DAMAGED PAINT

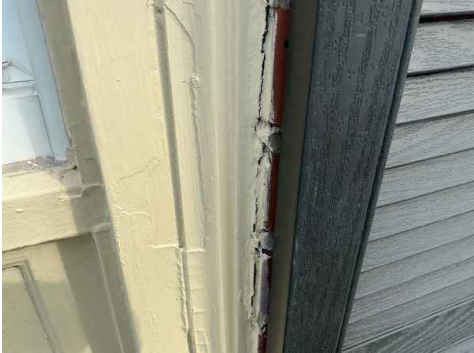
Window/wall caulk observed to be damaged. Condition risks moisture intrusion and damage.

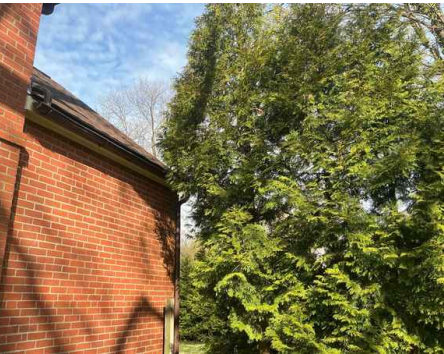
Right Exterior

Vegetation was noted to be growing adjacent to or on the exterior wall. Vegetation that is too close to the exterior of the building can hold moisture and promote rot, harbor vermin and insects, and create physical damage during windy weather. Removal of vegetation to create a 6-12 inch clearance between the vegetation and the wall is recommended.

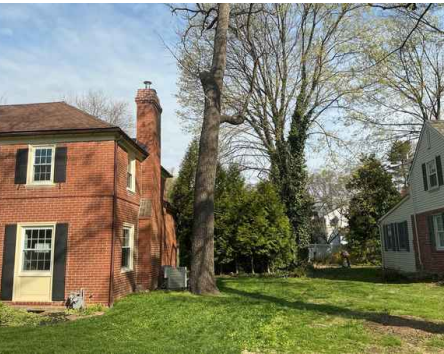
Right Exterior

One or more trees were noted to be located close to the building elevation. Trees that have close proximity to buildings can affect the foundation, pipes and electric laterals with their roots.

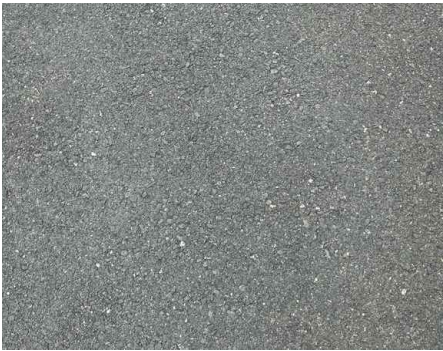
Driveway: Sealcoating Advised

Application of asphalt sealcoating of the driveway is advised.

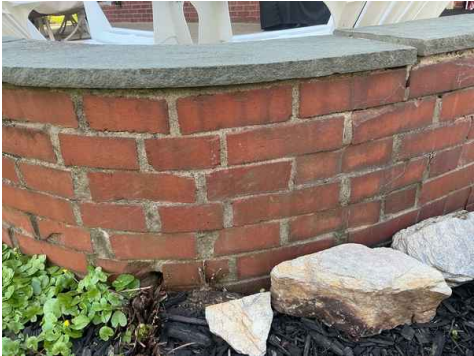
WALL: DAMAGE

Damage observed at the masonry wall. Necessary repair is advised.

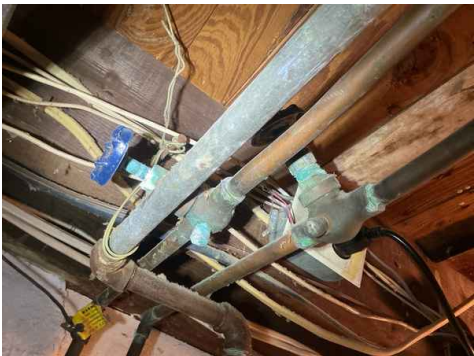
WATER SHUT-OFF: CORROSION

Corrosion observed at shut-off valve(s). NOTE: Valves are not operationally tested during a home inspection. Corroded valves should be monitored for leakage and future repairs undertaken as necessary.

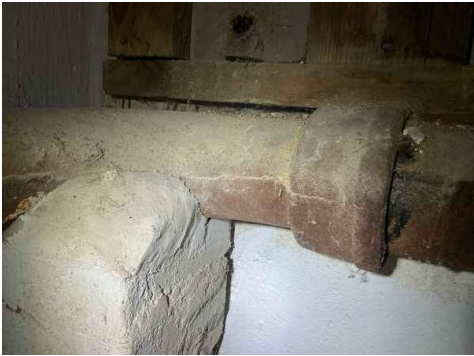
8.3.1 Waste and Drain Piping

WASTE: CRACKED

Waste pipe observed to be cracked. Further professional evaluation along with necessary repair/replacement is advised.

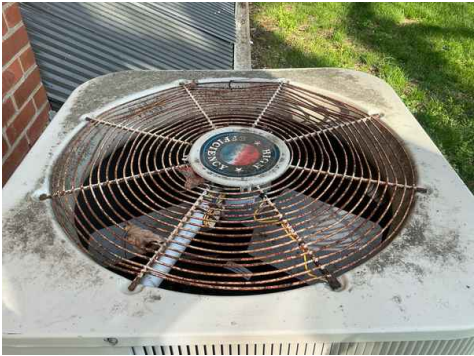
CONDENSER: CORROSION

Corrosion was observed at the condenser. Further evaluation and professional servicing is advised.

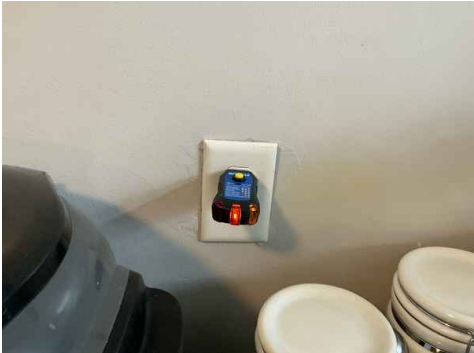
Ungrounded 3 prong receptacle(s) were observed. Further evaluation and corrective action is advised.

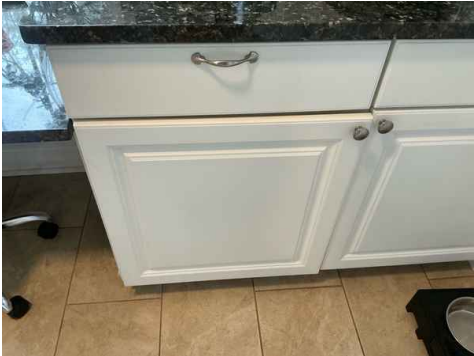
10.7.1 Cabinet/Countertop

CABINET: DOOR ADJUSTMENT

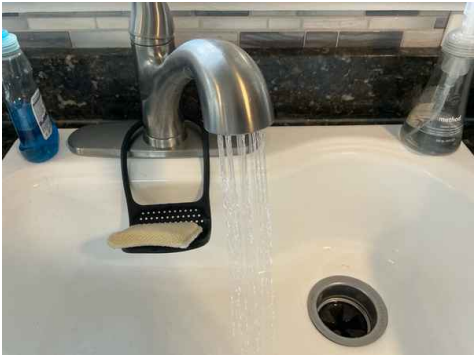
10.8.1 Kitchen Sink

FLOW: LOW PRESSURE

Low water flow was noted at the sink faucet. Recommend further evaluation along with necessary corrective action.

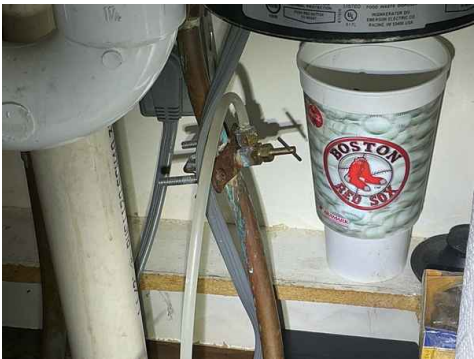
10.8.2 Kitchen Sink

SUPPLY: CORROSION

Corrosion observed at the water supply to the sink. Recommend repair/replacement.

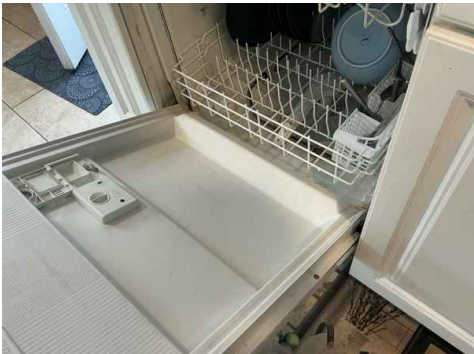
10.12.1 Dishwasher

DOOR: SPRING/COUNTERBALANCE DAMAGED

Dishwasher counterbalance/springs did not function as intended. Condition risks damage to the dishwasher as well as personal injury. Recommend evaluation by a qualified appliance technician along with necessary repair.

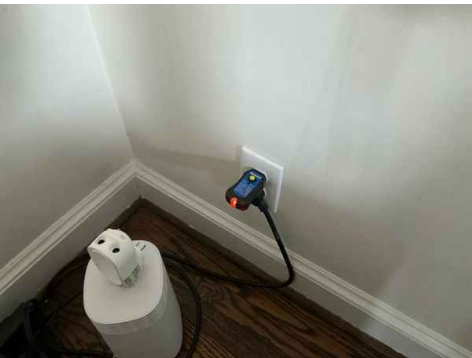
Ungrounded 3 prong receptacle(s) were observed. Further evaluation and corrective action is advised.

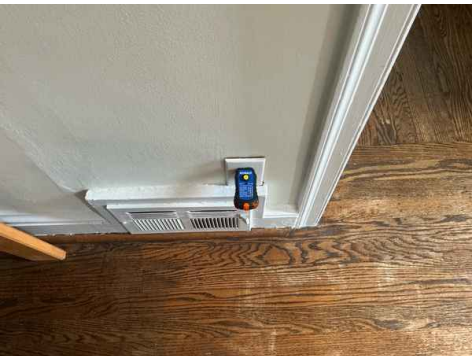
Ungrounded 3 prong receptacle(s) were observed. Further evaluation and corrective action is advised.

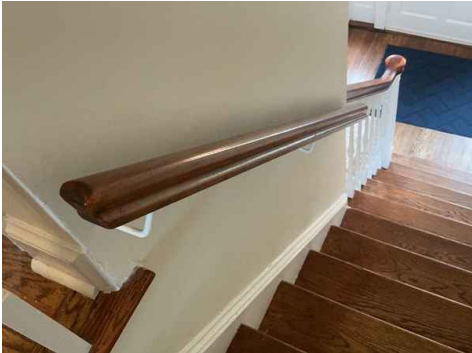
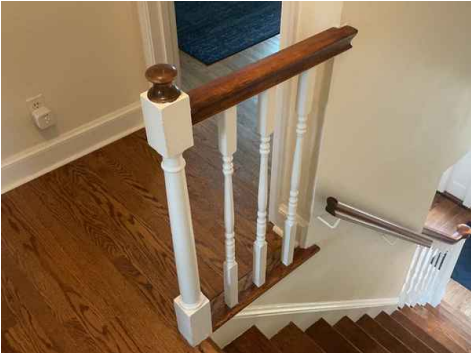
HANDRAIL(S): LOOSE

Loose handrail(s) observed. Repair/replacement is advised for safety.

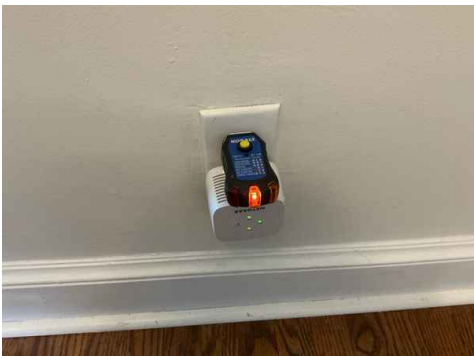
Ungrounded 3 prong receptacle(s) were observed. Further evaluation and corrective action is advised.

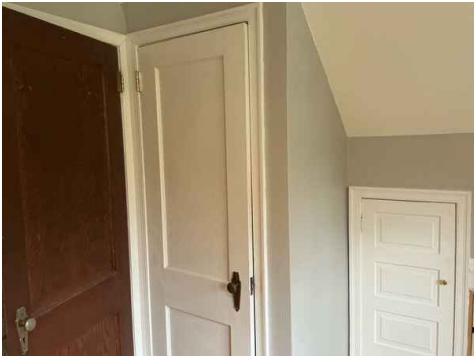
Closet door adjustment(s) are advised for proper operation.

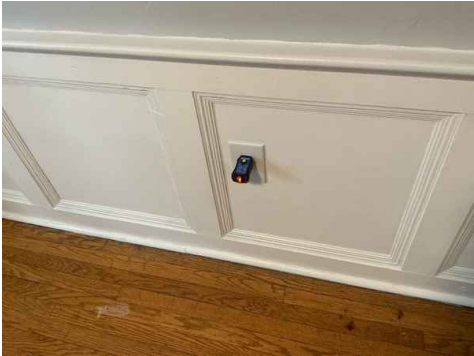
17.6.1 Interior Electrical

RECEPTACLE: UNGROUNDED 3 PRONG

Ungrounded 3 prong receptacle(s) were observed. Further evaluation and corrective action is advised.

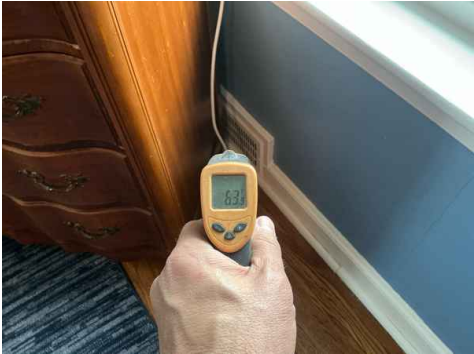
19.7.1 Room Heating/Cooling

RADIATOR: NO HEAT

No heat noted at the radiator. Further professional evaluation and necessary repair is advised.

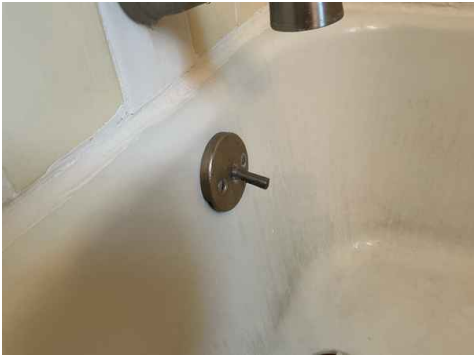
Tub stopper was inoperable. Repair/replacement is advised for proper operation.

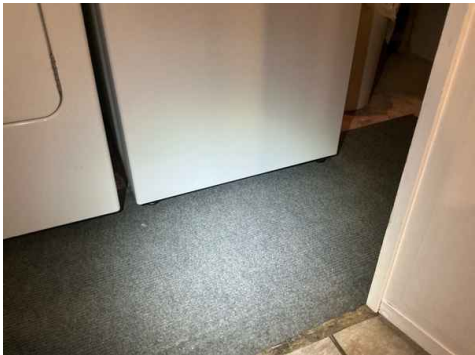
The clothes washer is located in an area where leaks could create interior damage. Recommend the installation of an auxiliary drip pan under the clothes washer. The pan should be plumbed to waste or have an alarm installed as a warning system for leaks.

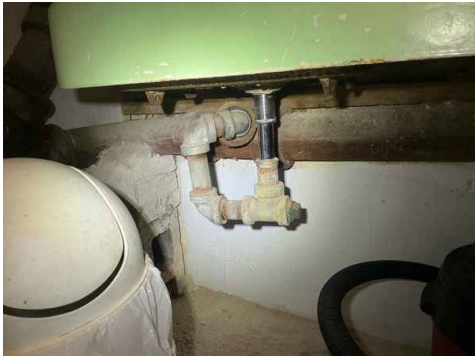
22.5.1 Laundry Sink

DRAIN: TRAP ABSENT

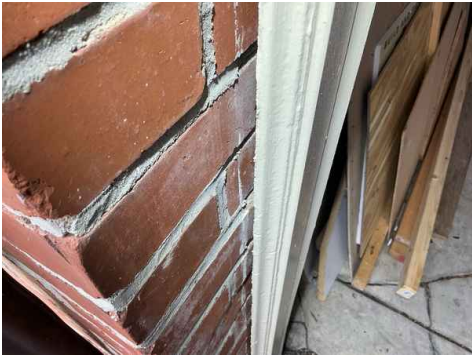
CAPPING CAULK ABSENT/DAMAGED

Garage vehicle door caulk observed to be absent/damaged. Condition risks moisture intrusion and damage.

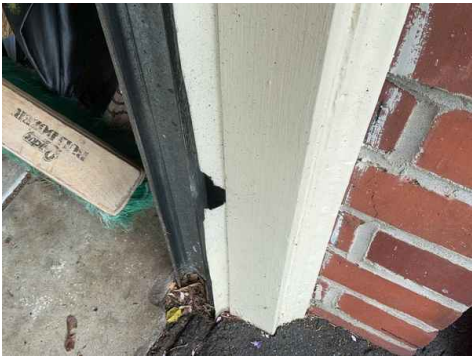
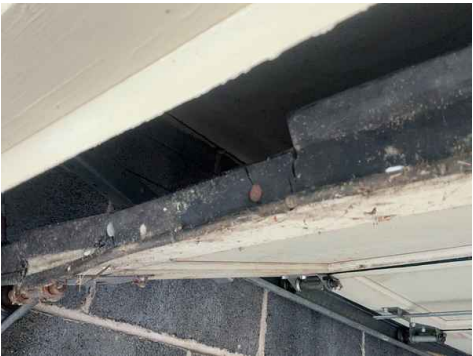
Garage vehicle door weather stripping improvements are advised for improved weather and thermal performance.

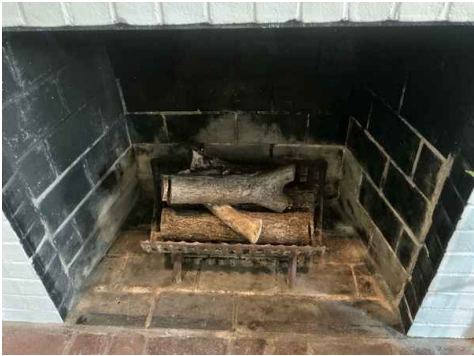
Due to conditions observed at the fireplace/stove, further evaluation, cleaning and professional inspection is advised prior to use.

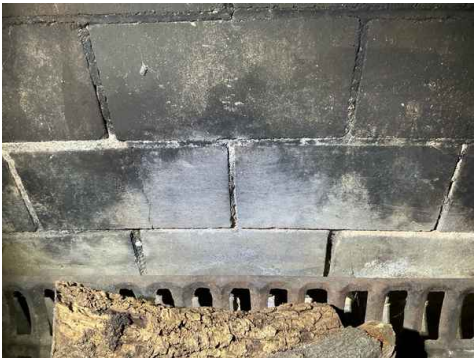
FIREBOX: MORTAR DETERIORATION

Damaged and/or absent mortar was noted at the interior of the masonry firebox. The mortar should be repaired or replaced as needed. Additional evaluation and necessary repairs should be undertaken by a qualified chimney sweep.

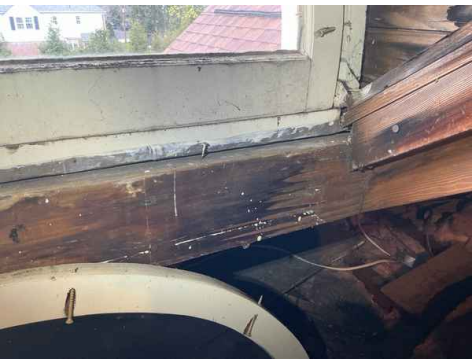
25.6.1 Attic Moisture Intrusion?

H2O DAMAGE - DRY

Moisture damage observed. Moisture meter testing measured non-elevated. Identification of the damage source and obtaining relevant historical information is advised. Further professional evaluation and repair should include, not limited to: interior finish damage, potential hidden damage, and damage source(s).

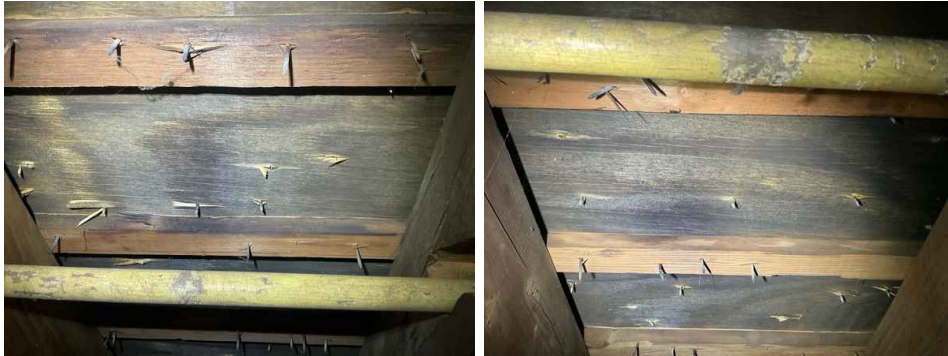
25.7.1 Mold/Fungal Growth

MOLD/FUNGAL GROWTH

Unknown biological substance/staining (suspected mold growth) observed. Air quality, testing and identification is outside the scope of this inspection and was not performed. Further professional consultation is advised by a qualified individual to determine the source and available remediation options.

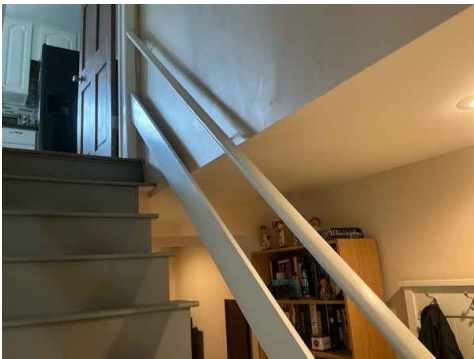
26.4.1 Handrail(s)/Guardrail(s)

HANDRAIL(S): LOOSE

Loose handrail(s) observed. Repair/replacement is advised for safety.

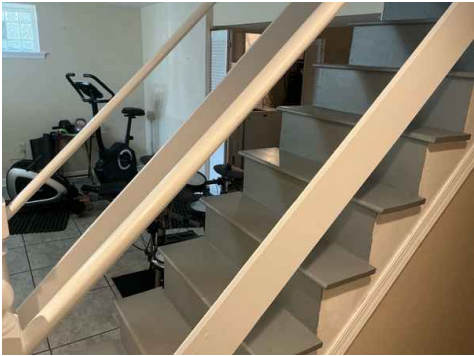
26.4.2 Handrail(s)/Guardrail(s)

INSTALLATION: OPENINGS > 4" - RAILING SYSTEM

Openings greater than 4 inches observed in the railing system. Condition presents a potential fall/entrapment risk, especially for young children. Repair/replacement is advised for safety.

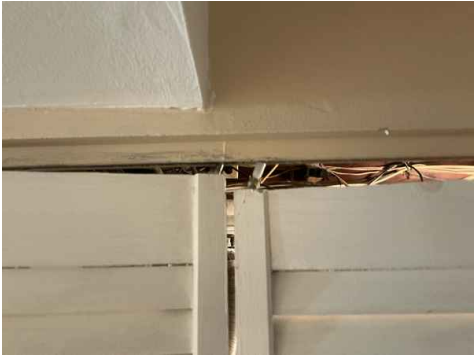
26.6.1 Door(s) Interior

HARDWARE: DAMAGED

Door hardware was observed to be damaged or inoperative. Corrective action is advised.

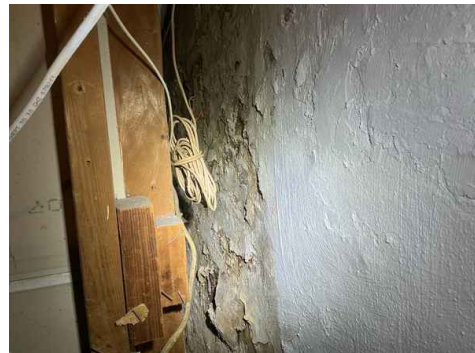
26.8.1 Basement Moisture Intrusion

TYPICAL/STAINING/EFFLORESCENCE

The basement shows evidence of moisture penetration (staining and efflorescence in areas). It should be understood that it is impossible to predict the severity or frequency of moisture penetration on a one-time visit to a home. Virtually all basements exhibit signs of moisture penetration and virtually all basements will indeed leak at some point in time. Further monitoring of the basement will be required to determine what improvements, if any, will be required. Inspection of the basement is based on what is accessible and visible at the time of the inspection only. It does not preclude or warranty against the possibility of future moisture intrusion/penetration.

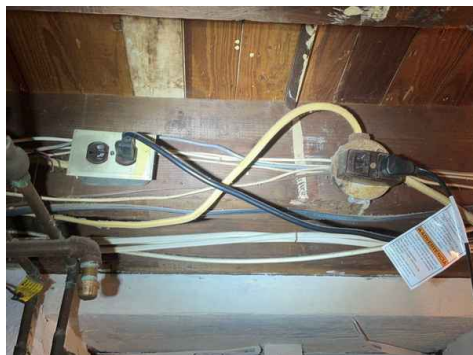
26.9.2 Interior Electrical

GFCI: ABSENT

Absent GFCI receptacle protection observed in an advised location. Installation is advised.

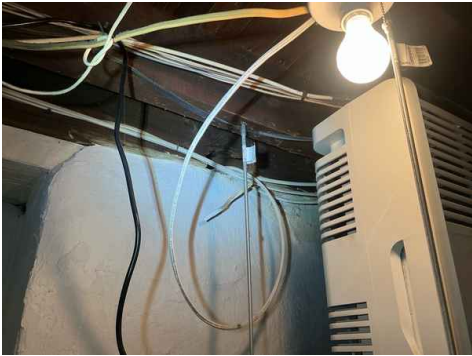
26.9.3 Interior Electrical

WIRE: LOOSE

Loose wiring observed. Securing is advised.

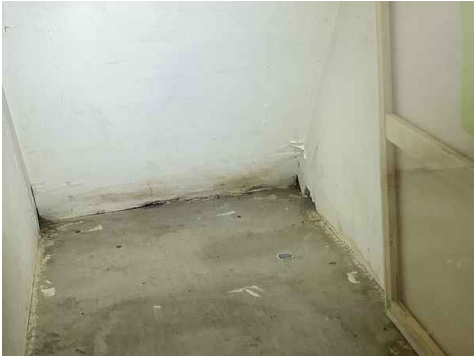
26.11.1 Mold/Fungal Growth

MOLD/FUNGAL GROWTH

Unknown biological substance/staining (suspected mold growth) observed. Air quality, testing and identification is outside the scope of this inspection and was not performed. Further professional consultation is advised by a qualified individual to determine the source and available remediation options.
